Re: Yeshivath Viznitz
Special Permit Application
235 Elm Road, Briarcliff Manor, NY

Building Inspection Report for Howard Johnson Hall

235 Elm Road,
Briarcliff Manor, NY 10510
(Aug 11th, 2021)

Building Inspection Report for Hillside House

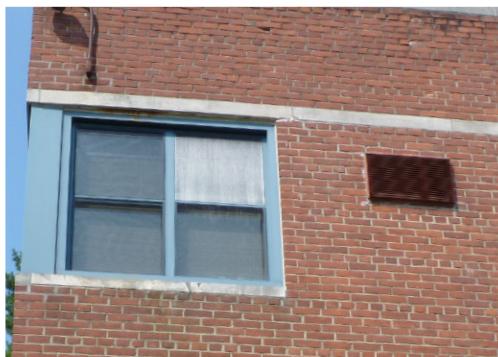
PICTURE #17

- Brick wall at left elevation is in fairly decent conditions except for chipped / damaged bricks in a few areas.
- The 6" precast concrete band above the second floor windows appears to be in fair conditions except for sporadic chips on the surface and above lintels which should definitely be repaired and patched to prevent future water infiltration. (PICTURE #17)

- Parapet wall precast concrete coping and window sills need to be power washed and cleaned properly. (PICTURE #17, #19 & #20)
- Existing HVAC louvers to be checked & secured and all around louvers shall be sealed as necessary.

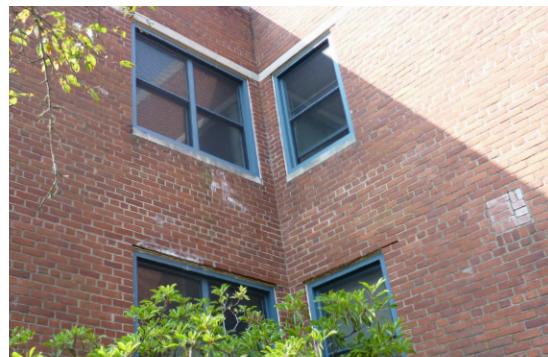
PICTURE #18

- Brick efflorescence was observed at indicated locations. (PICTURE #18)
- Some existing steel window lintels were rusted. Window caulking was deteriorated at multiple locations. (PICTURE #18 & #19)

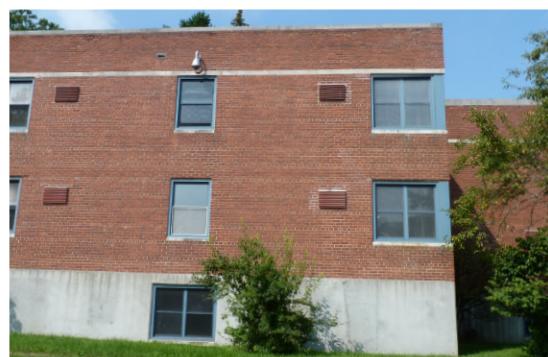
PICTURE #20

- Scuppers were found at the left elevation and no downspouts were connected to the scuppers. Rain from the scuppers is draining directly on the facade surface. (PICTURE #20)

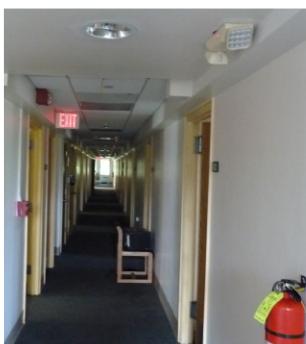
PICTURE #28

- The interior concrete structural floor (with commercial carpet flooring), dropped acoustic ceiling in the hallways, gypsum board ceiling in rooms, 6" CMU interior partition walls and light weight stud walls are all in fairly decent conditions. (PICTURE #28 & #34)
- Existing stairs and railing are up to code with blasters at 4" O.C. and proper height from finish floor surface. (PICTURE #29)
- Existing bathroom fixtures are in good condition but perhaps in need of some cosmetic upgrades. (PICTURE #30, #32)
- Radiator covers at both ends of the 2nd floor hallway were damaged. (PICTURE #35)
- Signs of severe water infiltration and damages to interior of building was noted above window in direct correspondence with compromised and badly rusted steel lintel on the exterior facade of the building. (PICTURE #33)

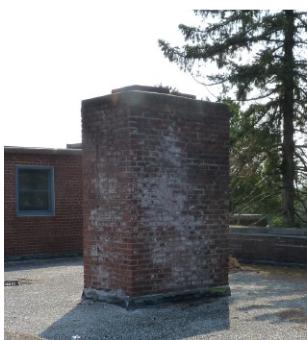
PICTURE #36

- Chipped bricks and brick efflorescence was observed on parapet wall. (PICTURE #36, #39 & #42)

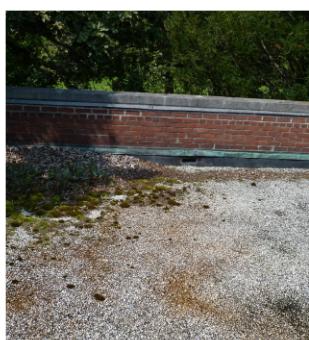
PICTURE #37

- Scuppers were not connected to the downspouts and rain is draining directly on the building facade surface. (PICTURE #42)
- Some minor vegetation growth was observed on the roof which can probably be removed with a thorough cleaning. (PICTURE #37 & #43)

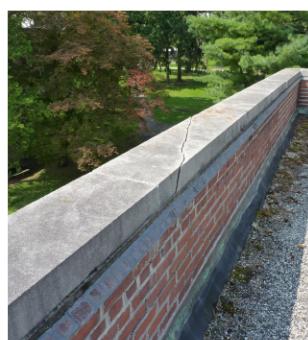
PICTURE #38

- One precast parapet coping unit is completely damaged and needs to be replaced ASAP. Immediately underneath the precast coping, 2 or 3 courses of bricks have been dislodged and are detaching from the rest of the interior parapet surface. (PICTURE #38 & #42)

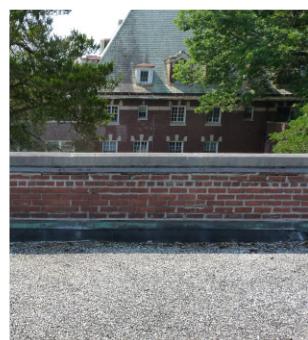
PICTURE #39

- Existing reglets all around interior surface of parapets walls, bulkhead walls and chimneys are in bad conditions and need to be properly secured. (PICTURE #39, #42 & #43)

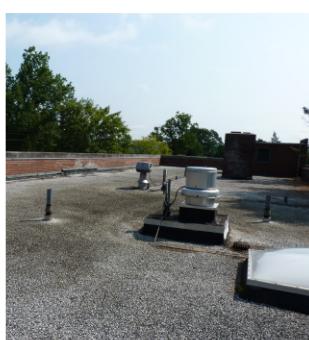
PICTURE #41

- In general, the existing roof seems to be in fairly decent condition and no obvious leakage was found at the 2nd floor ceiling.
- Existing EPDM membrane seems to be in fair condition and no obvious damage was observed. (PICTURE #41)

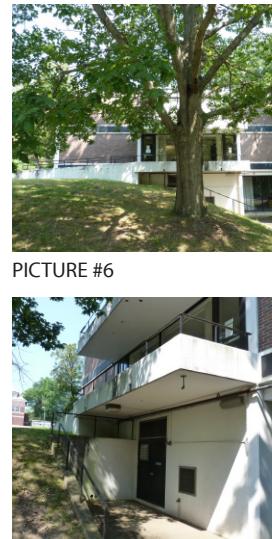
PICTURE #6

- Right elevation was in fair condition. (PICTURE #6)
- The exterior balconies' railings do not appear to be up to code and further investigation will be necessary. (PICTURE #7, #8)
- Concrete panels underneath the balconies appear to be properly fastened, although showing signs of peeling paint at many areas. (PICTURE #7, #8)
- Exterior concrete structure shows signs of water dripping and overflow from the roof on all facades. Extensive power washing will be necessary. (PICTURE #6, #7 & #8)

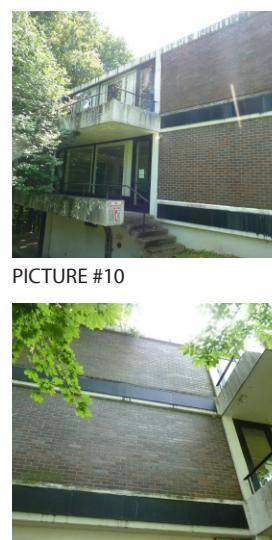
PICTURE #10

- Left elevation was in fair condition. (PICTURE #10)
- The exterior balconies' railings do not appear to be up to code and further investigation will be necessary. (PICTURE #11)
- Concrete panels underneath the balconies appear to be properly fastened, although showing signs of peeling paint at many areas. (PICTURE #12)
- Exterior concrete structure shows signs of water dripping and overflow from the roof on all facades. Extensive power washing will be necessary. (PICTURE #10, #12)
- (1) Decorative block fascia panel on left elevation fell off. All fascia panels especially the horizontal ones attached to the second floor structure need to be checked for proper and secure fastening to the backwall and properly sealed to prevent future detachment. (Picture #13)

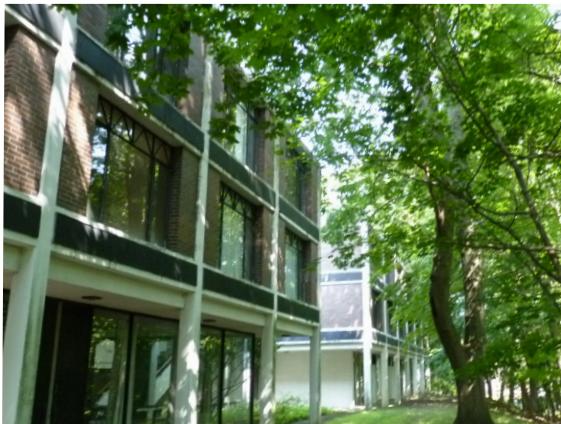
PICTURE #14

- Poured concrete structure & brick infills at rear elevation are in fairly decent condition except for some hairline cracks which do not appear to be structural. (PICTURE #14 to #17)
- Existing surface mounted black decorative fascias appears to be in bad condition. (PICTURE #15)
- Existing windows were single pane casement windows with central stationary panel. Existing window frames and miscellaneous wall panel inserts are not in good conditions and fenestration weather striping appears to be compromised. (PICTURE #14, #16)
- Exterior concrete structure shows signs of water dripping and overflow from the roof on all facades. Extensive power washing will be necessary. (PICTURE #15)
- Existing concrete panels underneath the 1st story structure appear to be properly fastened, although showing signs of peeling paint at many areas. (PICTURE #17)

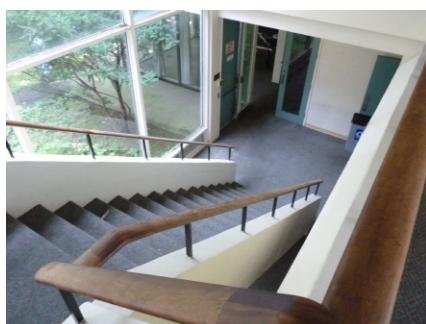
PICTURE #18

- The interior floors are structural concrete with commercial carpet flooring and 6" brick/CMU interior partitions. (PICTURE #18, #19, #20)
- Existing rooms are in good conditions with minor signs of water infiltration. (PICTURE #21)
- Existing stairs' railings are not up to code and further investigation will be necessary to assess existing railings and stairs in terms of sizes and ADA compliance. (PICTURE #22)
- Existing exit signs and emergency lights appears to be in fair condition but will definitely need to be tested by a licensed electrician. (PICTURE #19,#22)
- Existing bathroom facilities are still functional and in fair conditions.
- Some severe signs of water penetration were noted at both ends of the 2nd floor hallways. (PICTURE #23-a and #23-b)

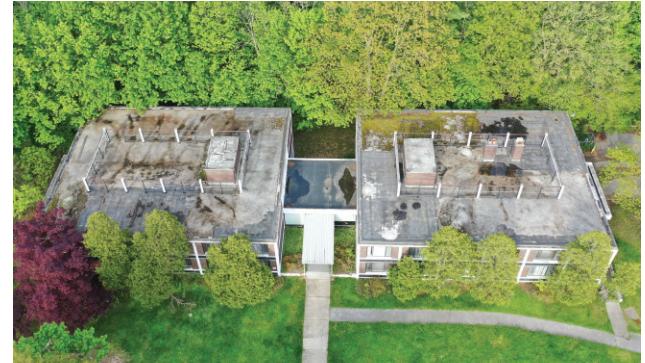
PICTURE #24

- Entire roof is severely compromised. The roof is not draining properly and there is considerable vegetation growth over the roof. (PICTURE #24 to #30)
- Entire roof is not properly pitched and ponding was observed pretty much everywhere. (PICTURE #24 to #30)
- Left side roof bulkhead is compromised, existing bulkhead ceiling is deteriorated. (PICTURE #28)
- Existing roofing EPDM membrane is in bad condition and should be replaced entirely. (PICTURE #29)
- Existing bulkhead walls and chimney reglets are in bad conditions. Also severe brick efflorescence was observed. (PICTURE #30)
