EXHIBIT B

March 8, 2023

Bridge Condition Assessment
Shadow Brook Lane Over Sparta Brook
Briarcliff Manor, New York, 10510, Westchester County
Colliers Engineering & Design Project No. 23004045A

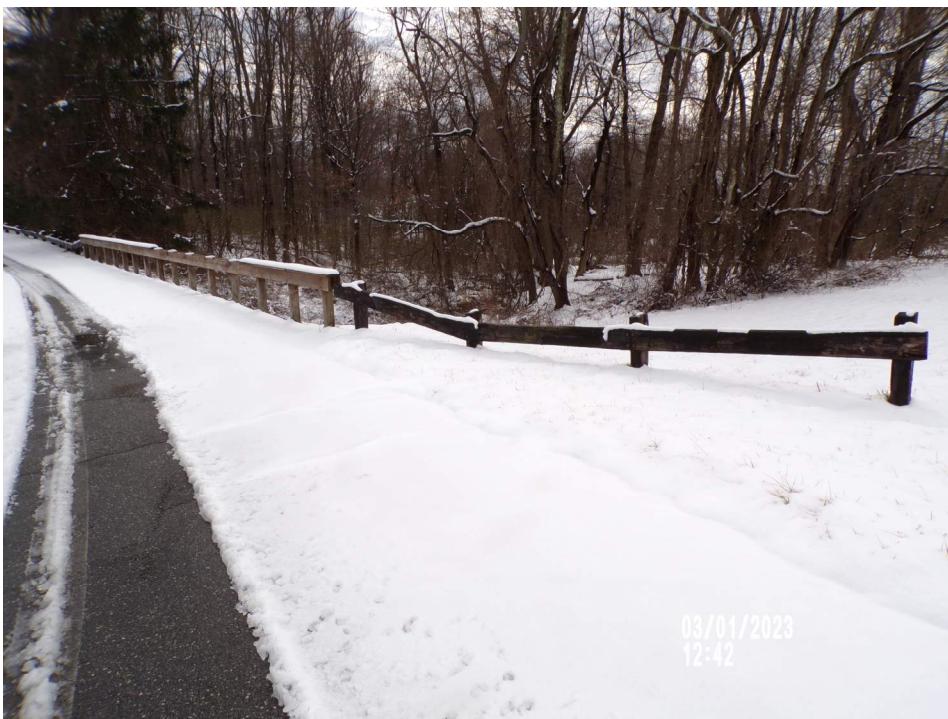
- The timber bridge rail (along concrete curbs) and timber approach rail appeared to be in poor condition, with missing/displaced members and connections observed throughout.

Photograph 2. Bridge Rail/Approach Rail, South Side

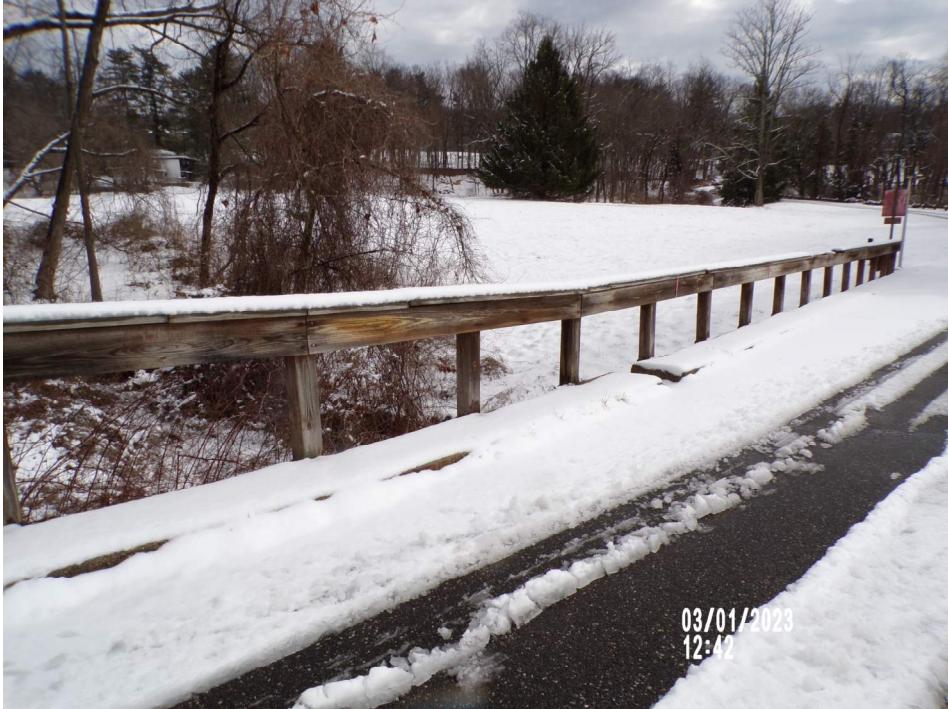
Photograph 3. Bridge Rail/Approach Rail, North Side

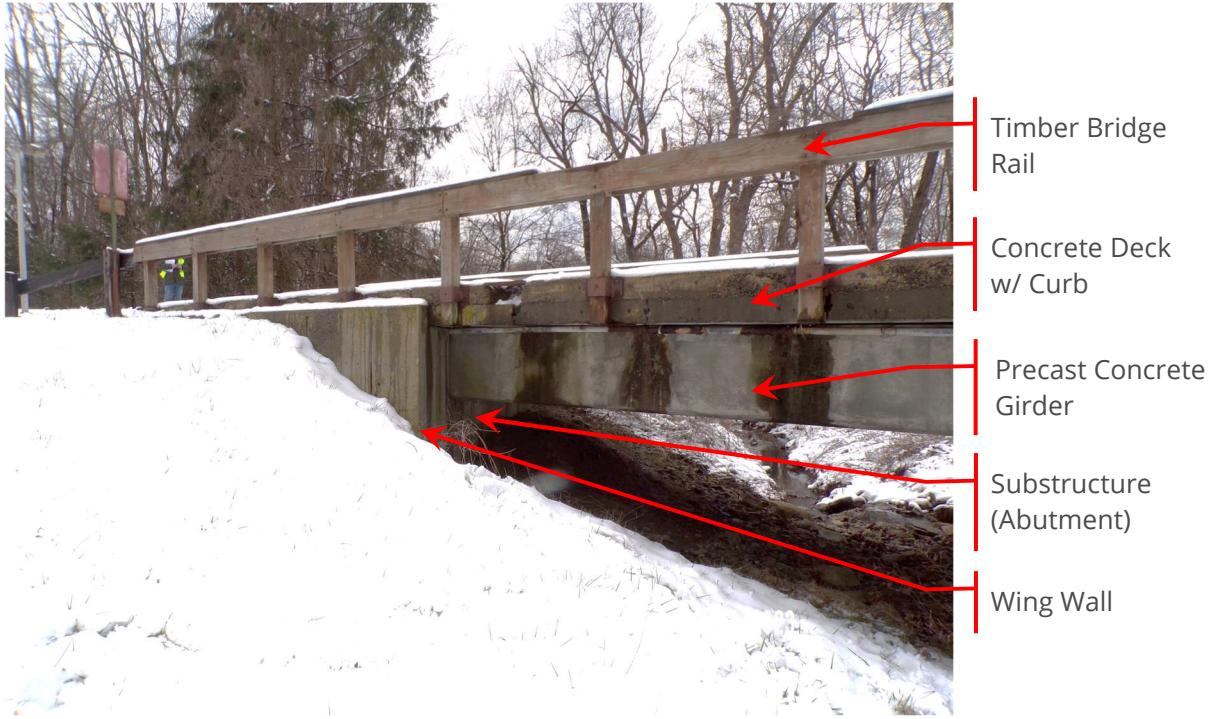
Photograph 5. East Abutment of Bridge

- The reinforced concrete abutment walls and wingwalls (substructures) appeared to be in fair condition, with small cracks/spalls observed throughout.

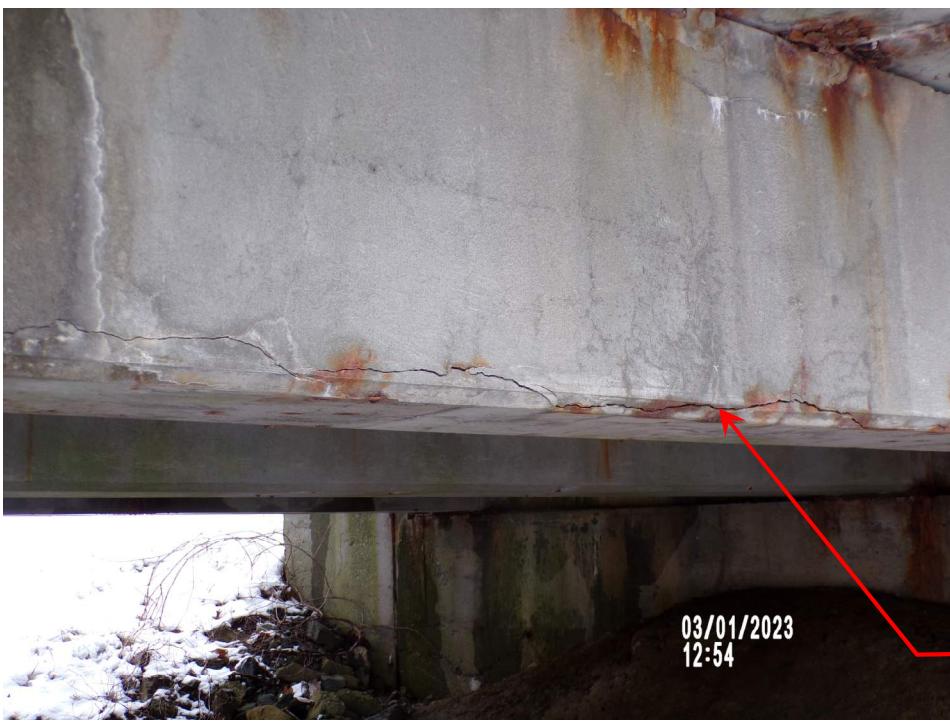
- Cracks (ranging from small to large in size) and spalls with efflorescence were observed throughout.
 - Large horizontal cracks were observed along the bottom sides of all 3 girders at or near the midspan locations.

Photograph 10. Horizontal Crack Along Bottom of Precast Girder, Underside of Bridge

We recommend that this bridge should be replaced with a new bridge structure that meets the current standards of AASHTO and NYSDOT. In the meantime, we recommend that only passenger type vehicles be allowed to cross the structure. Based on the bridge superstructure type and its advanced deterioration condition, there is no feasible or practical way to significantly strengthen the primary structural members of the existing bridge. Some repairs may be recommended in the interim to slow down the bridge deteriorations; but such repairs will not increase the bridge load carrying capacity.

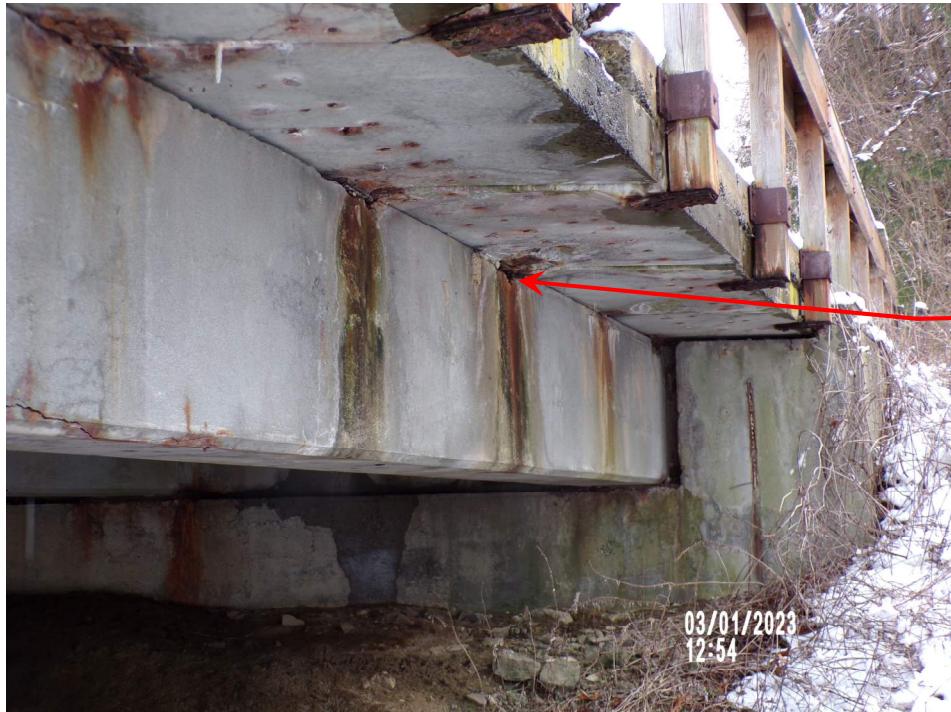
- Some staining resulted from the corrosion of exposed reinforcing bars that are exposed to the elements (water leakage, salt infiltration, etc.).
 - Some staining resulted from the corrosion of metal supports (between tops of precast concrete girders and bottom of precast concrete deck panels) that are exposed to the elements.

Photograph 11. Spalls and Signs of Corrosions, Underside of Bridge

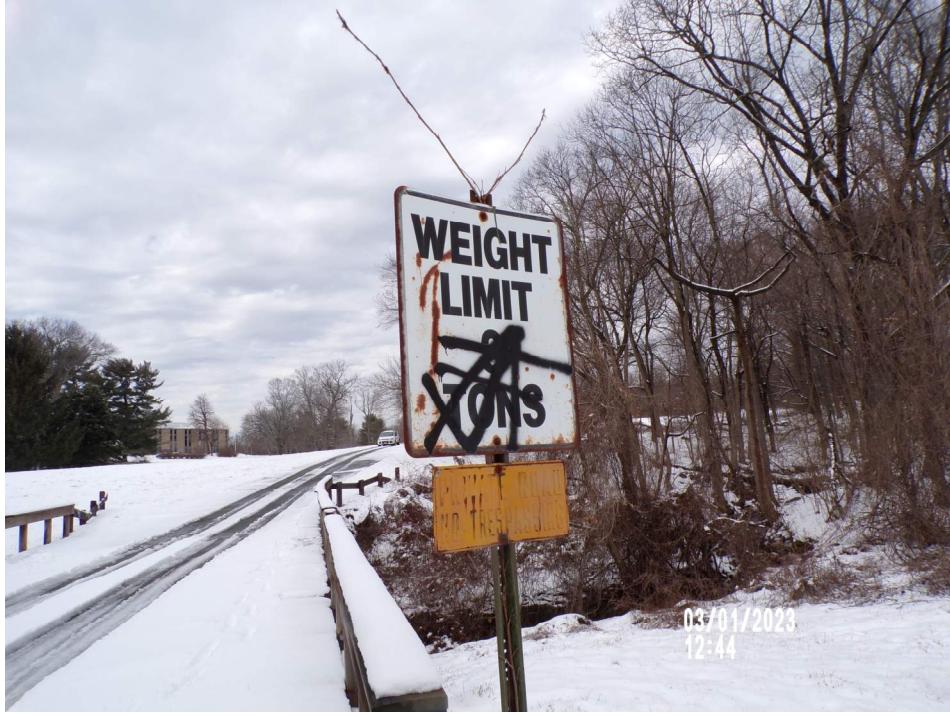
The bridge carrying capacity is very low based on the low load rating posted (3 Tons). The current posting for 3 Tons indicates that a load rating (and inspection) was previously performed and is likely documented in a previous inspection report. The previous inspection report, likely held by the previous owner, could be useful in assessing the progression of the deteriorations observed and noted above. However, the review of previous reports would not change our recommendations.

Photograph 17. 'WEIGHT LIMIT 3 TONS' Sign
