# **PHASE I ARCHAEOLOGICAL INVESTIGATION**

**Meadows at Briarcliff Subdivision  
715 Sleepy Hollow Road  
Briarcliff Manor, Town of Mount Pleasant  
Westchester County, New York 10510**

Historical Perspectives, Inc.  
PO Box 529  
Westport, CT 06881

**January 2022**

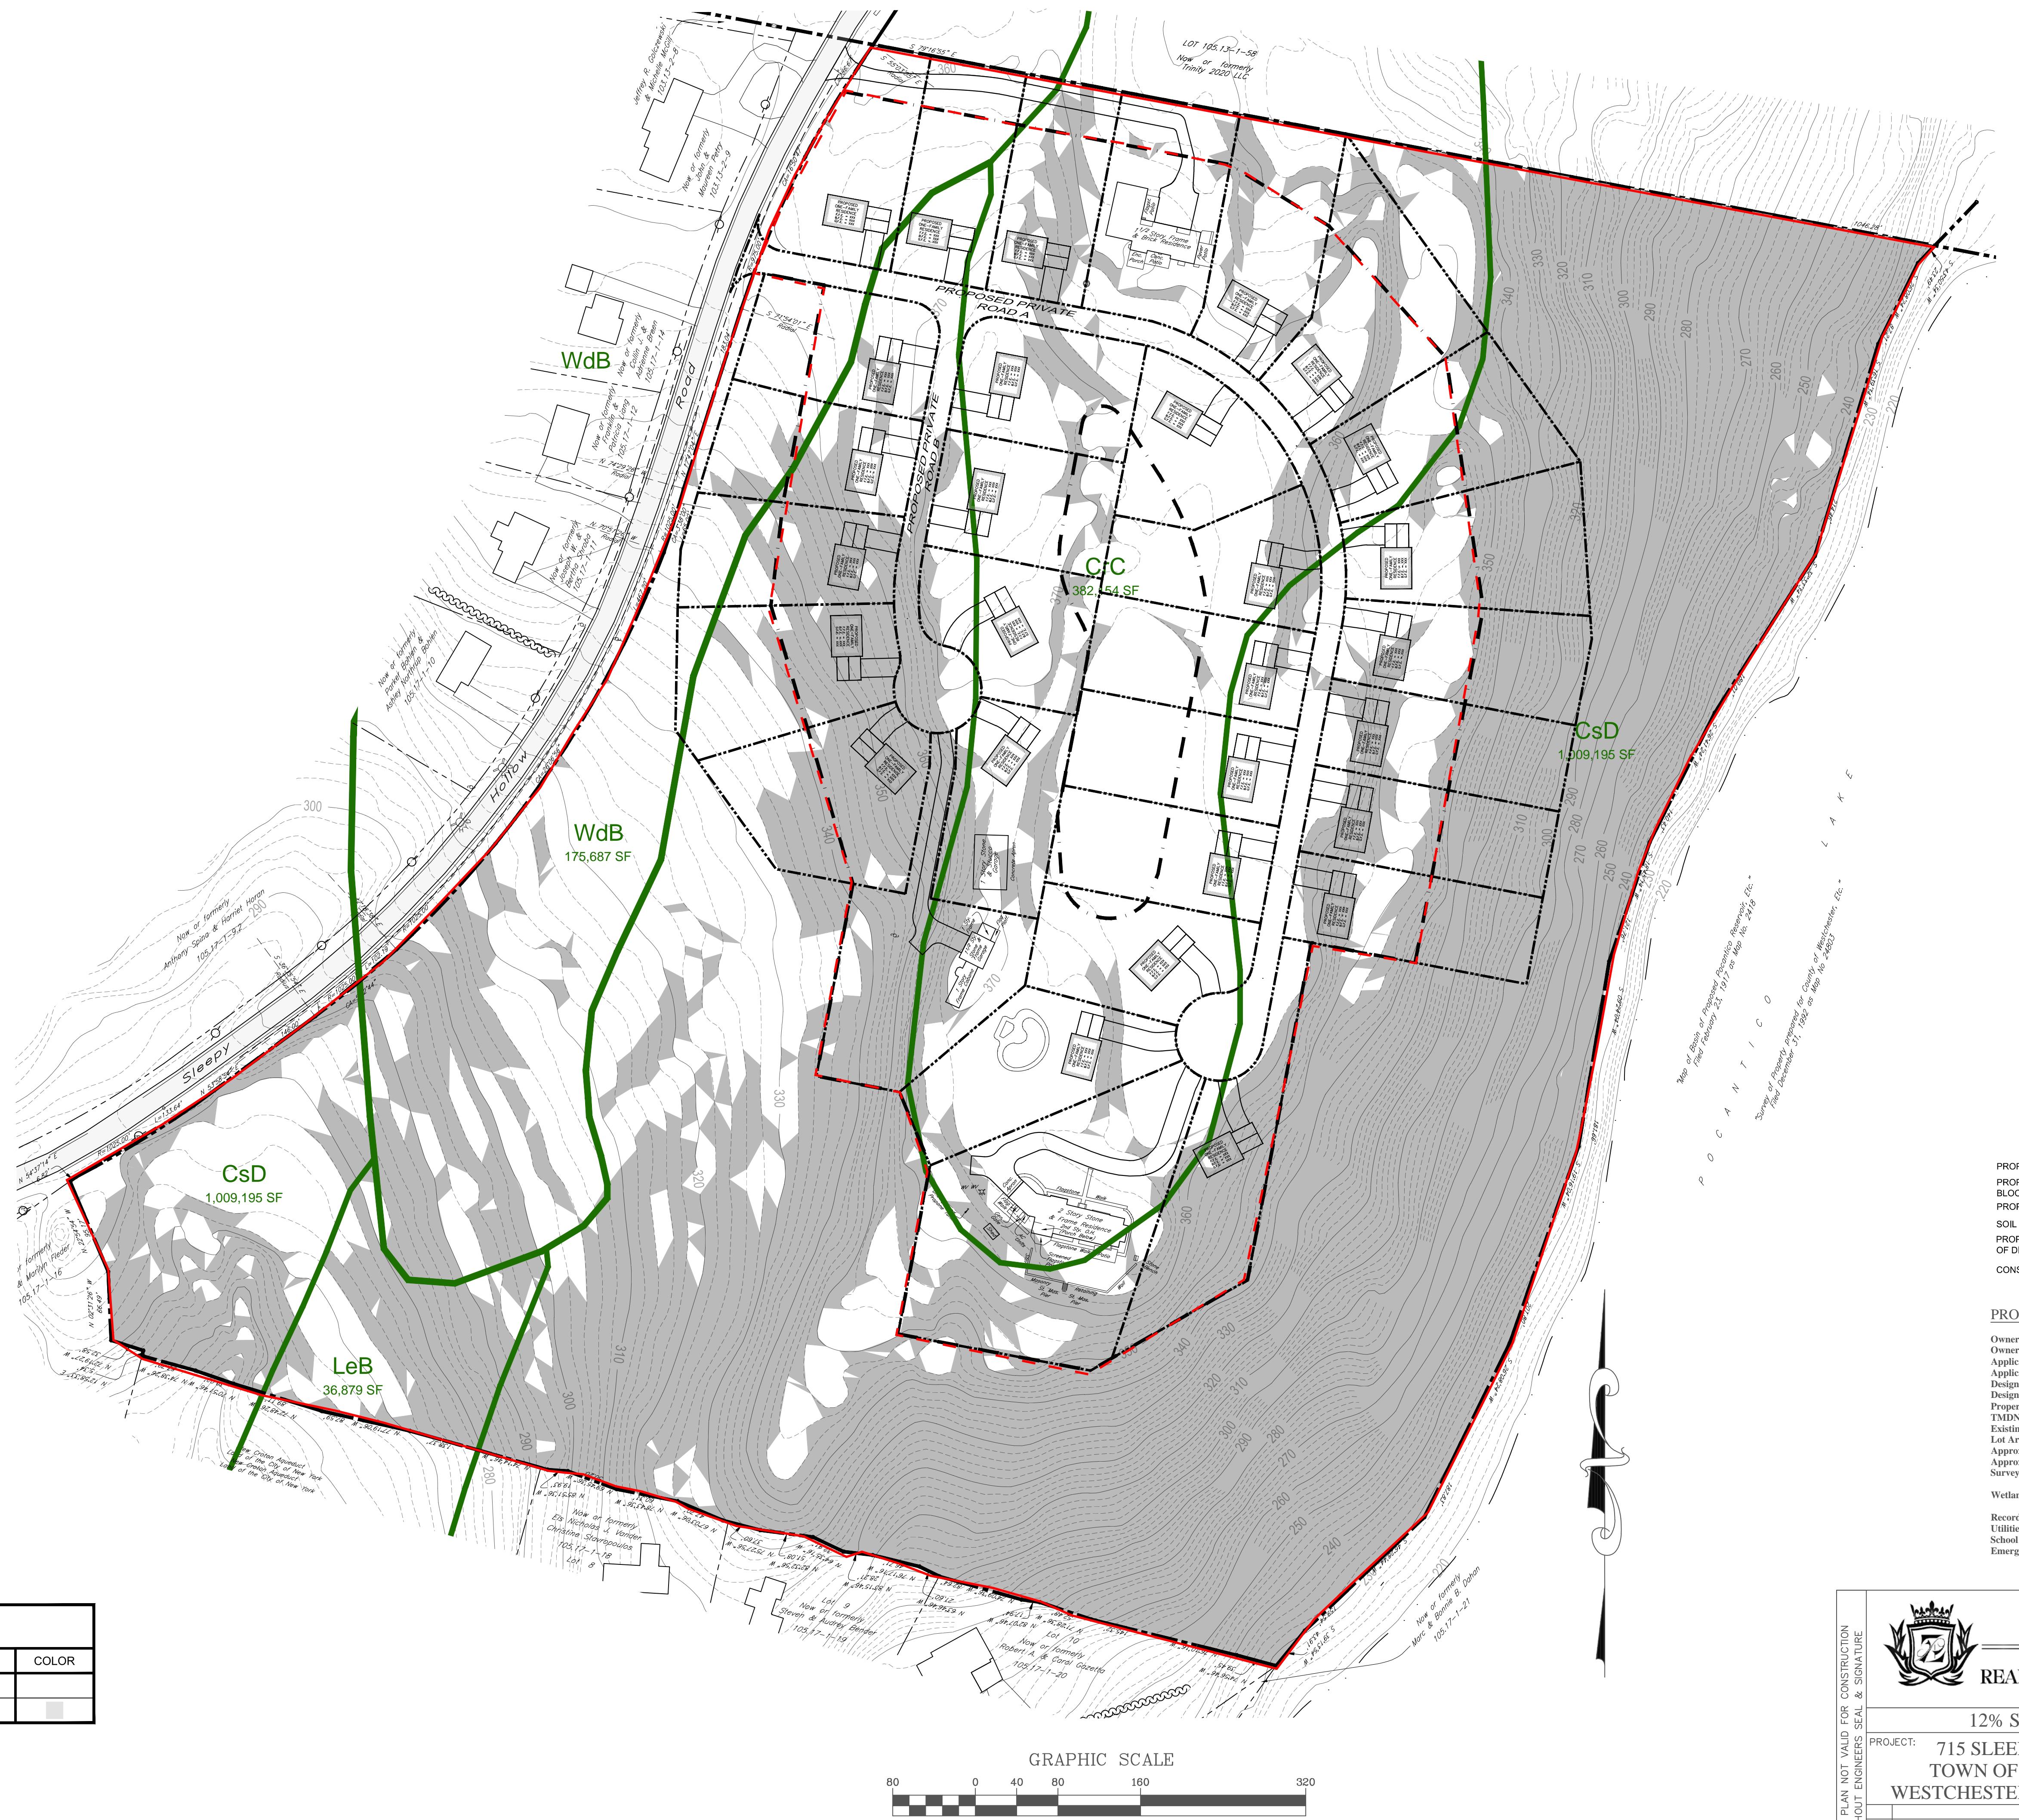
Figure 3. Project site and APE on site survey showing 12% slopes, soil boundaries, and proposed development (HPI 2021 and Zappico 2021).

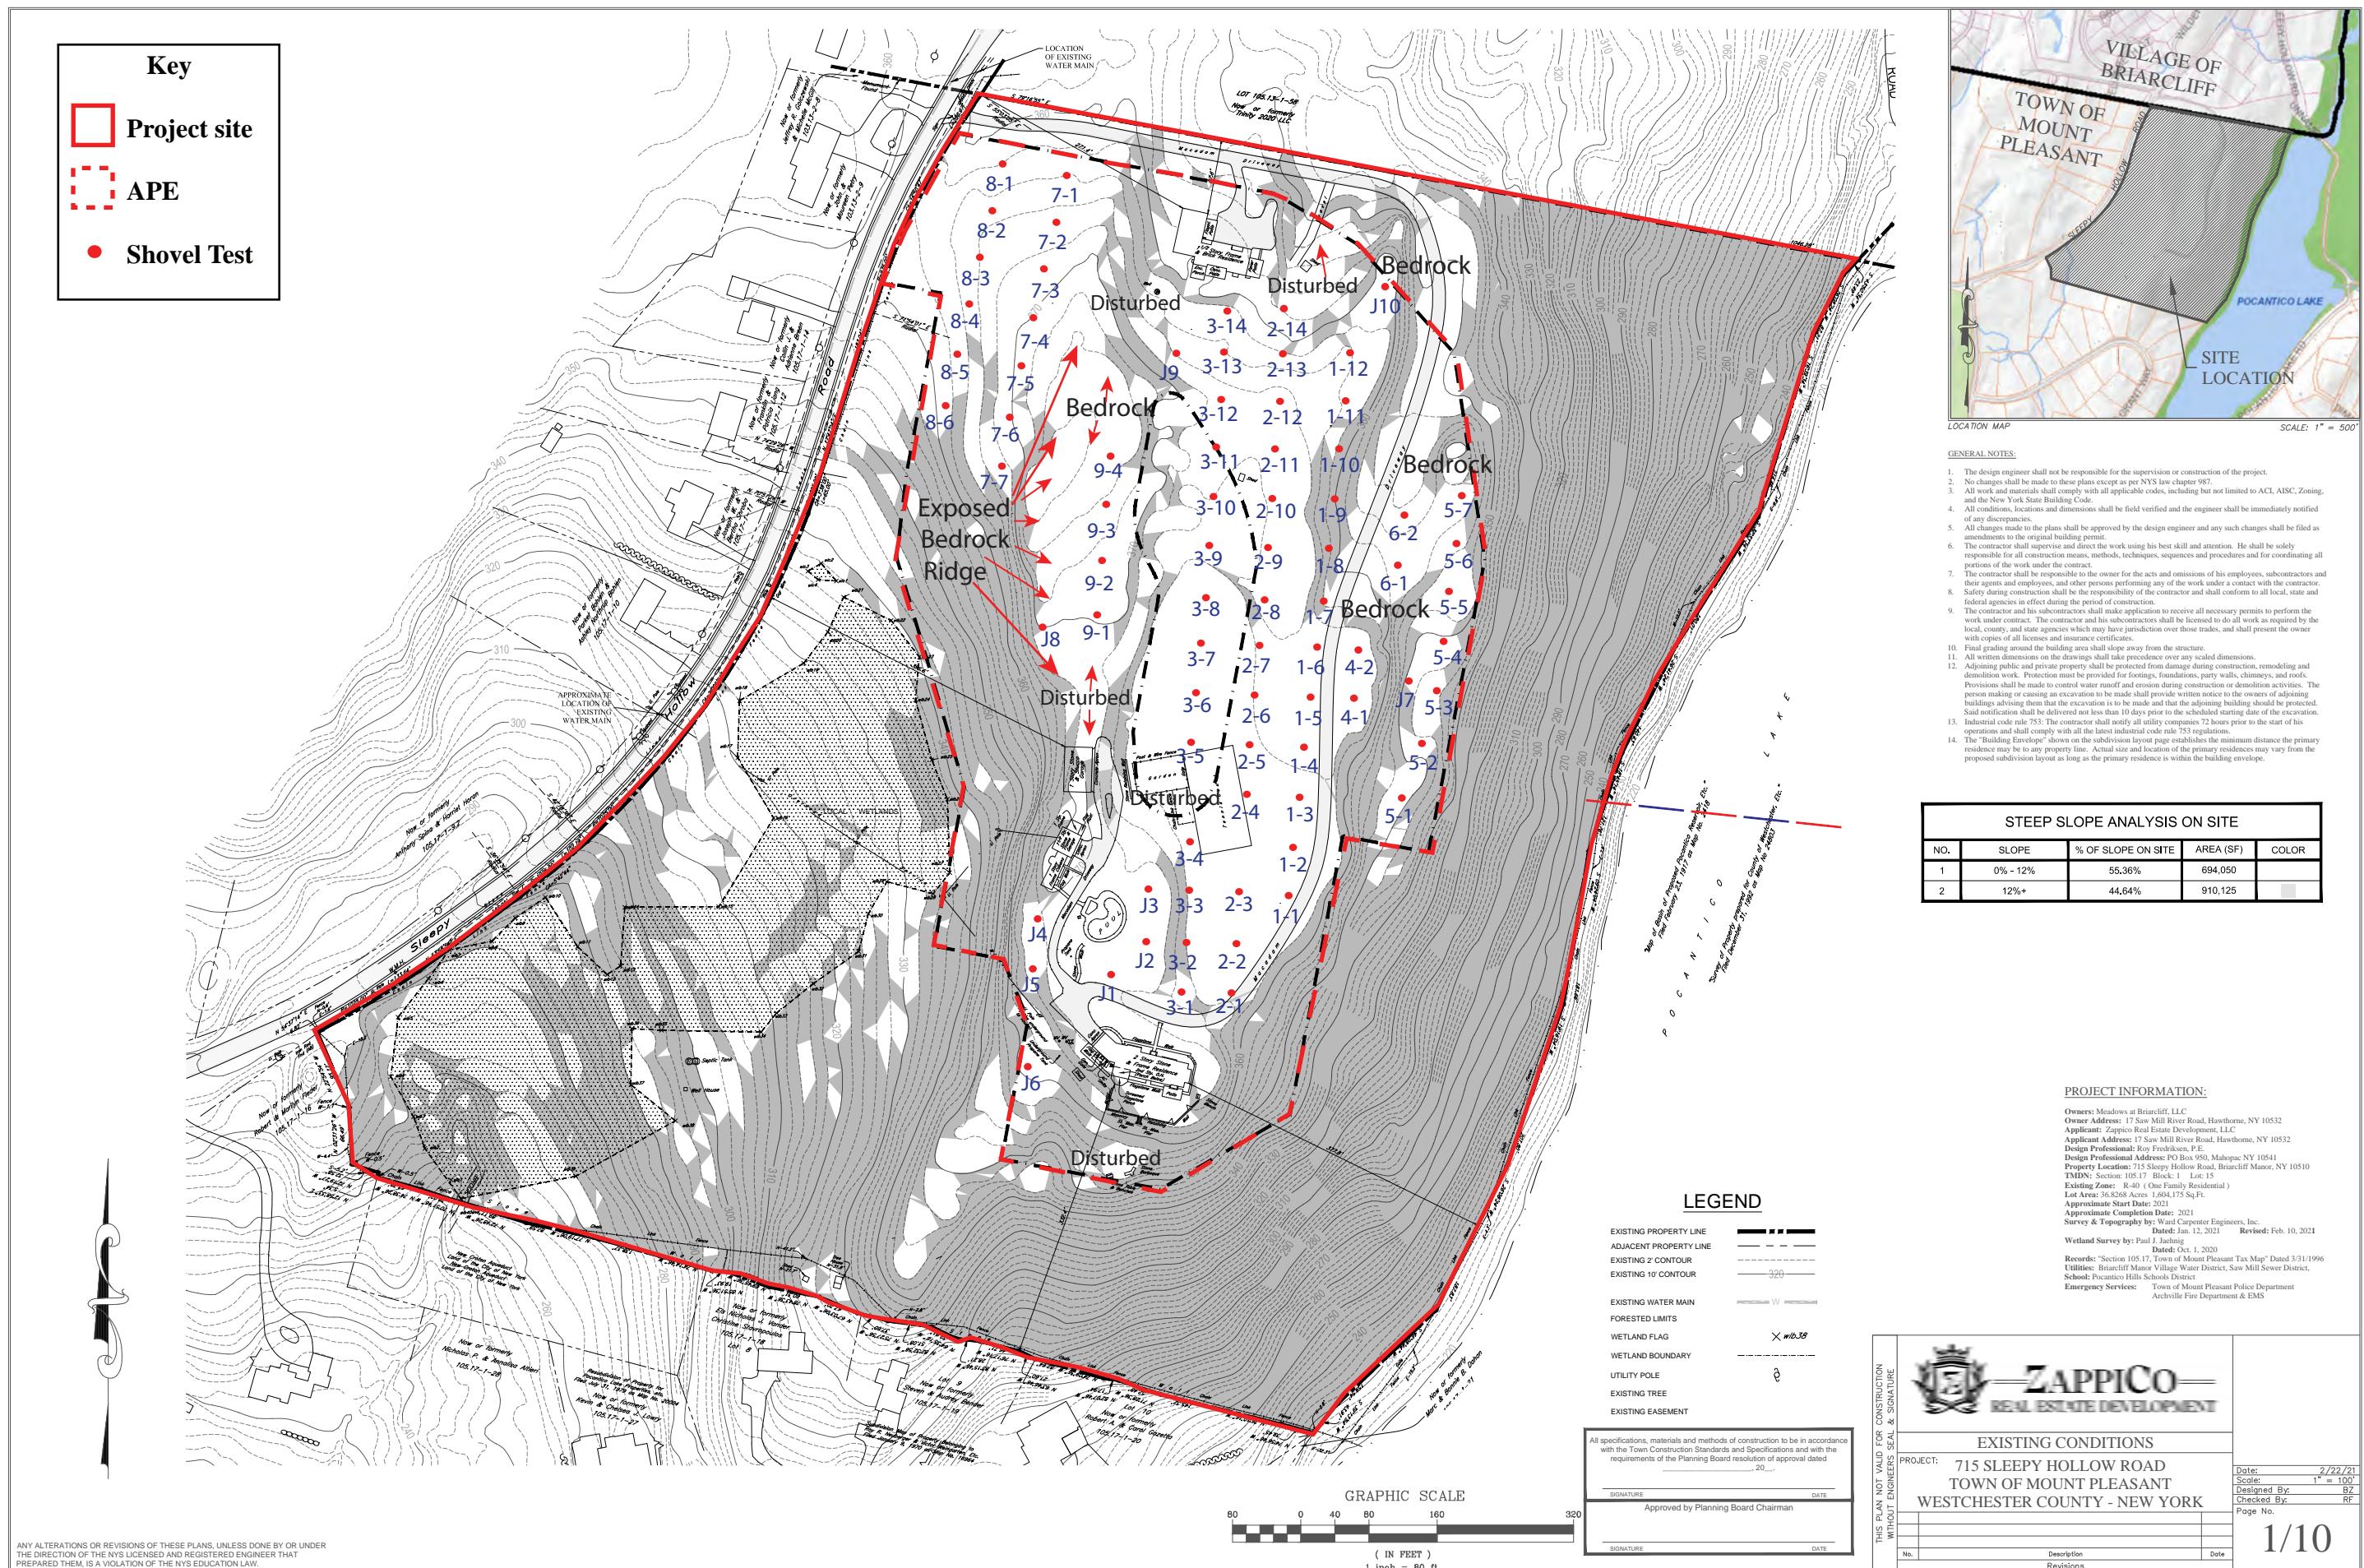
**Figure 15. Project site, APE, and locations of Shovel Tests on existing conditions survey (HPI 2021 and Zappico 2021).**

The results of the Phase IA assessment indicated that the project site is potentially sensitive for precontact archaeological deposits where slopes are less than 12%, there is no standing water, and the land is not obviously disturbed. Therefore, Phase IB archaeological testing, as per NYSOPRHP regulations, was recommended for those sensitive locations that coincide with the APE, as shown on Figure 15.

A total of 78 STs (40 cm x 40 cm) were investigated within the APE during the course of the Phase IB field testing project in November 2021 (Figure 15). Testing was not conducted in locations of excessive slope, where known disturbance had occurred, or where bedrock outcrops were present (Figure 15; see Photographs 17, 18, and 25). None of the bedrock outcrops appeared to have been used for precontact period rock shelters. In a few locations modern refuse piles were also observed. In addition, the immediate yard areas around the twentieth-century structures were not tested as the disturbance caused by their construction, surrounding grading and filling, and utility installations would have likely destroyed any potential precontact resources. Further, the yard surrounding the main residence was significantly altered by the construction, fire, and reconstruction of the house, followed by land alteration activities to create a flat yard with the stone retaining wall, seating areas, and the graded barbecue area at the southernmost edge of the APE (Figures 2 and 15; see Photographs 2, 5, and 7).

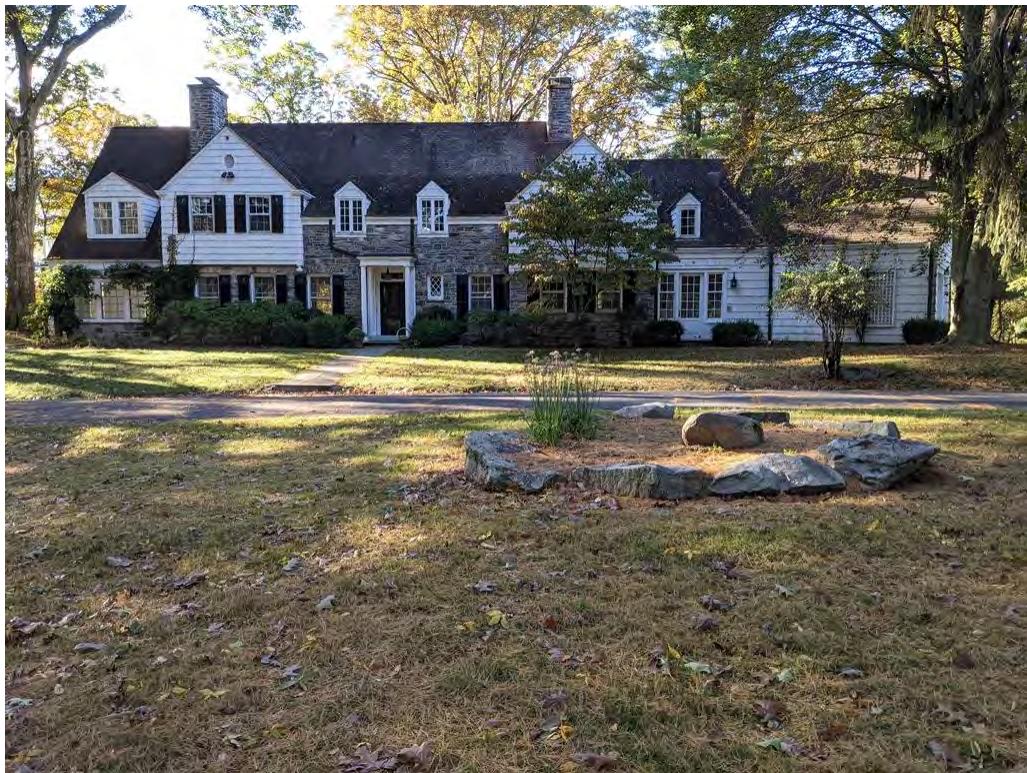
Photograph 1. Main house, front (north) elevation. View looking south.

The oldest structure on the property is the main residence, located at the southern end of the APE (Photographs 1-4). As will be described in more detail below, the central part of the house was constructed in 1928-1929, but then almost completely burned down in April 1929 (Appendix A). According to building permits on file with the Town of Mount Pleasant, the house was rebuilt after the fire that same year, and was altered and expanded in 1937, 1953, and 2000. The main house contains a combination of stone and frame construction. There is a large, artificially leveled terrace behind the house, surrounded by a substantial stone retaining wall (Photograph 5). A frame storage shed and a stone barbecue are located south of the terraced area, on a sloping hillside (Photographs 6 and 7).

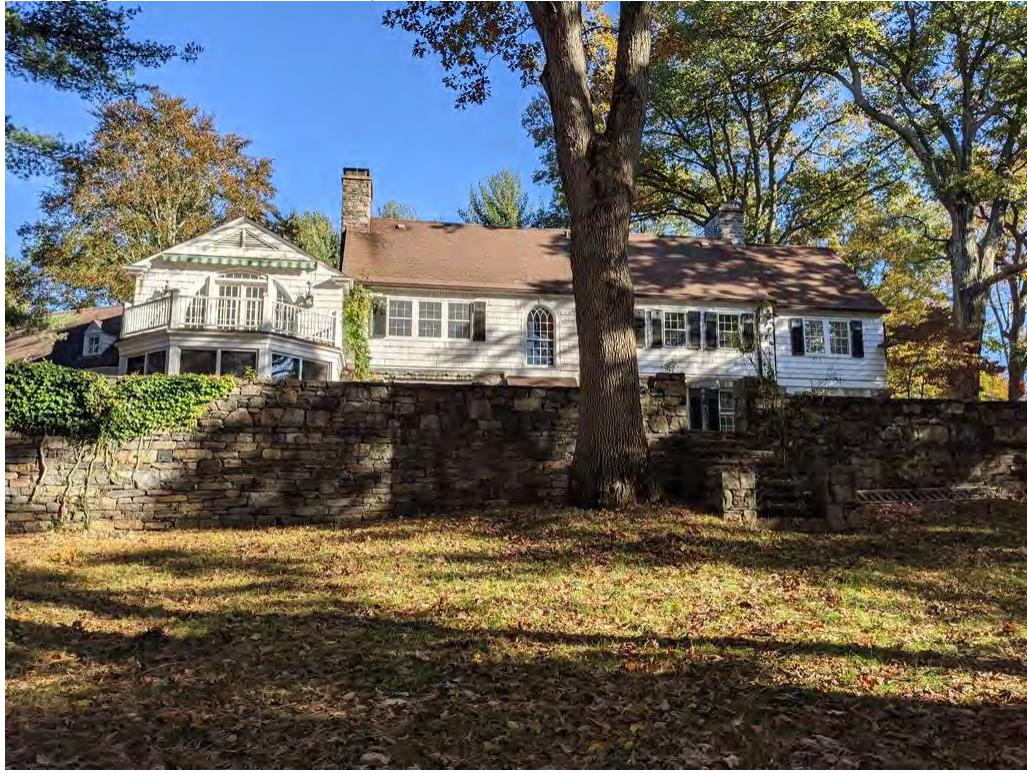
Photograph 2. Main house, rear (south) elevation with retaining walls and steps leading to back yard. View looking north.

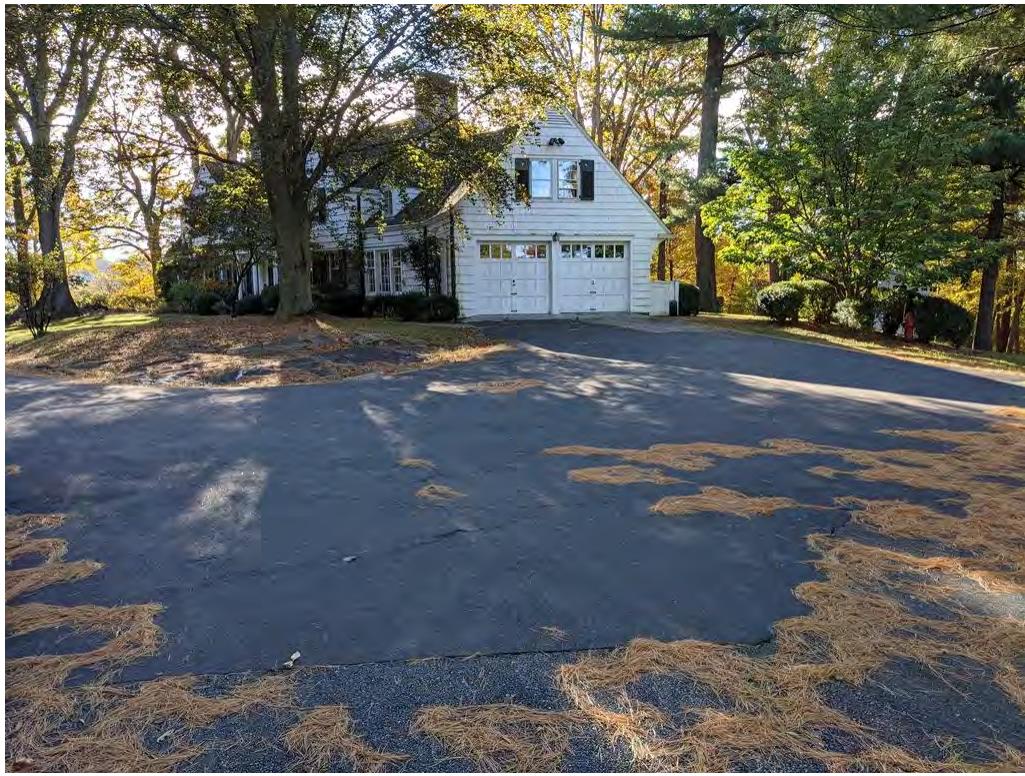
Photograph 3. Main house, west elevation, with garage and driveway. View looking southeast.

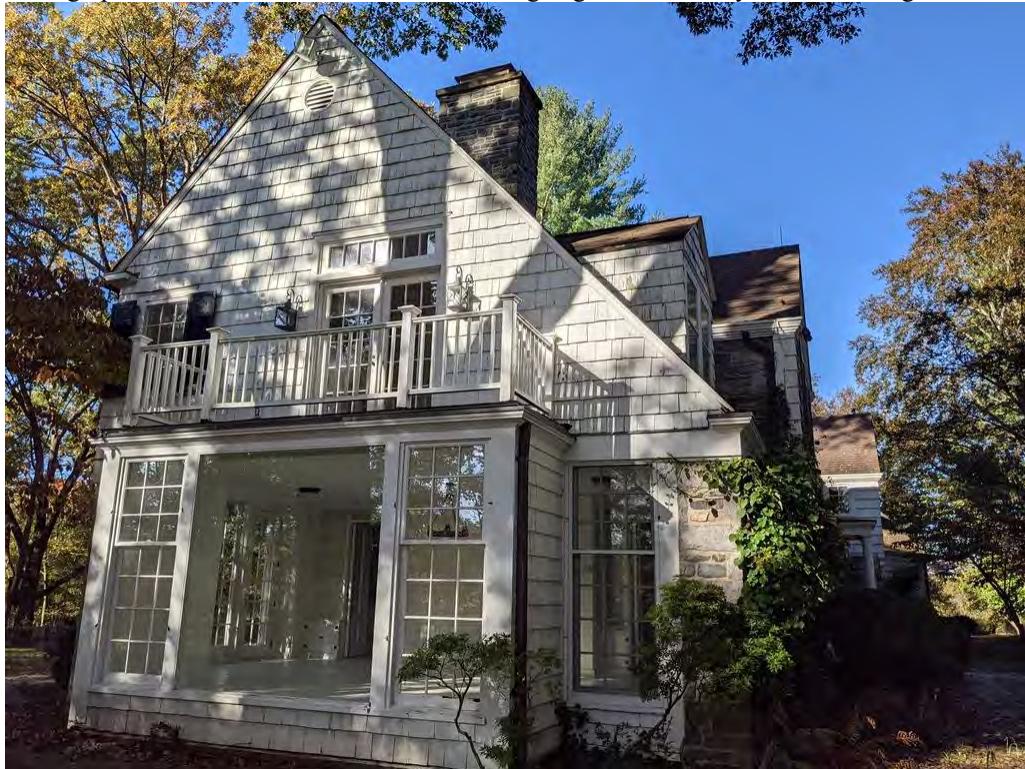
Photograph 4. Main house, east elevation. View looking southwest.

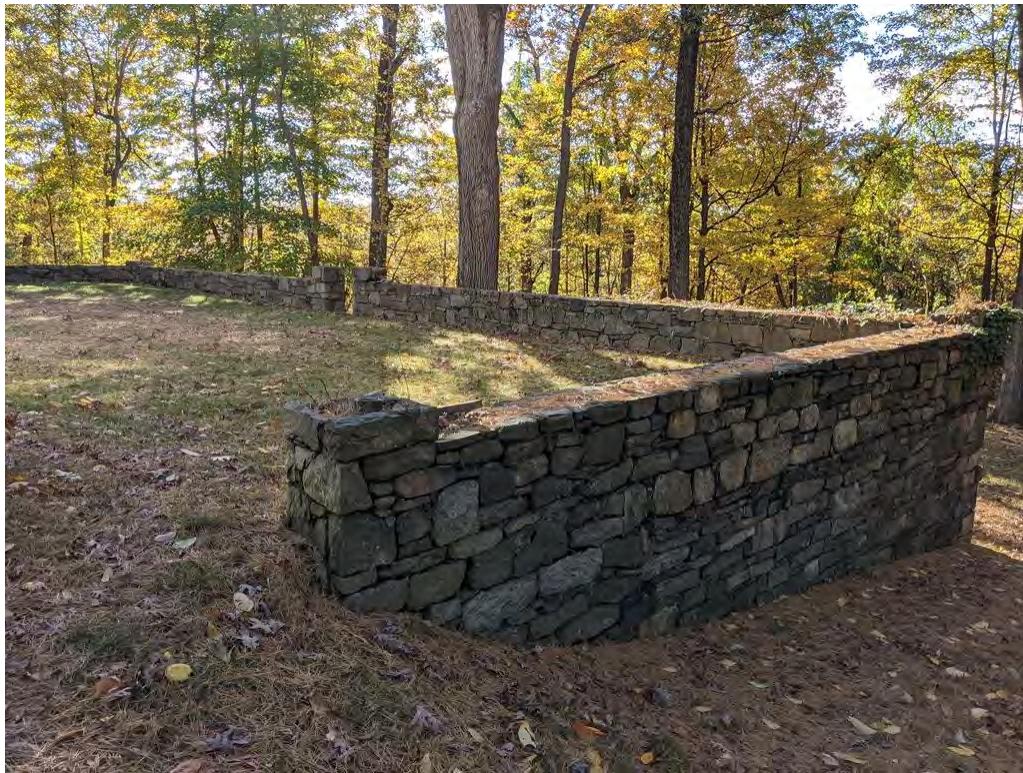
Photograph 5. Retaining walls enclosing the artificially leveled area to the south of the main house. View looking southeast.

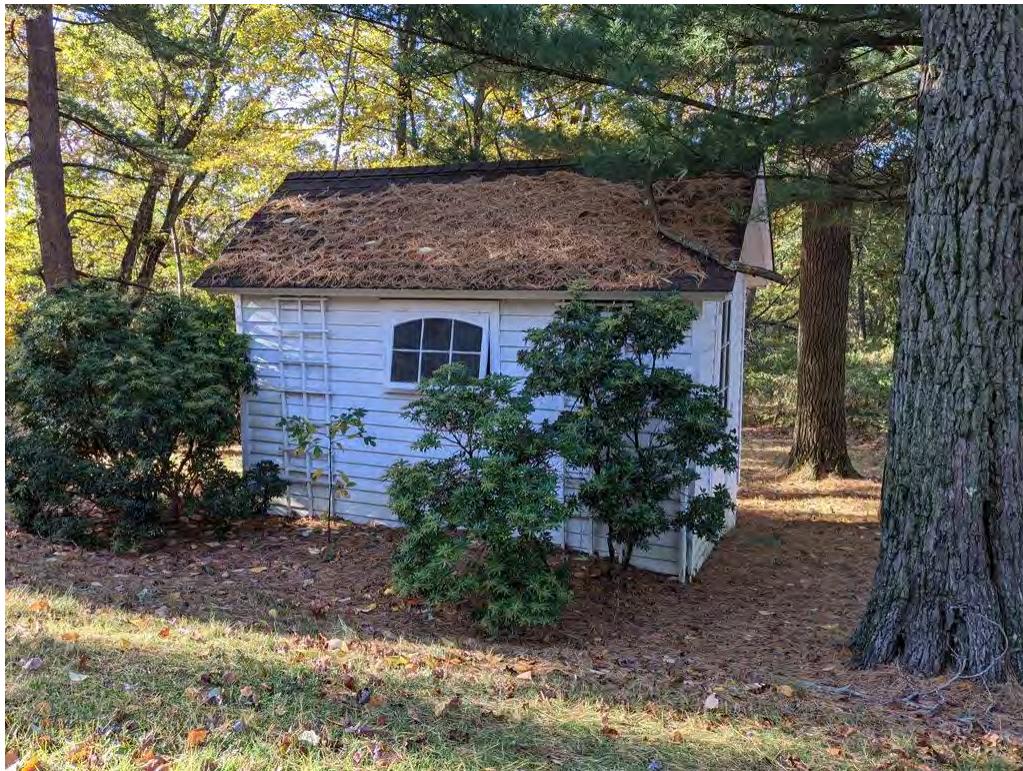
Photograph 6. Storage shed behind the main house. View looking south.

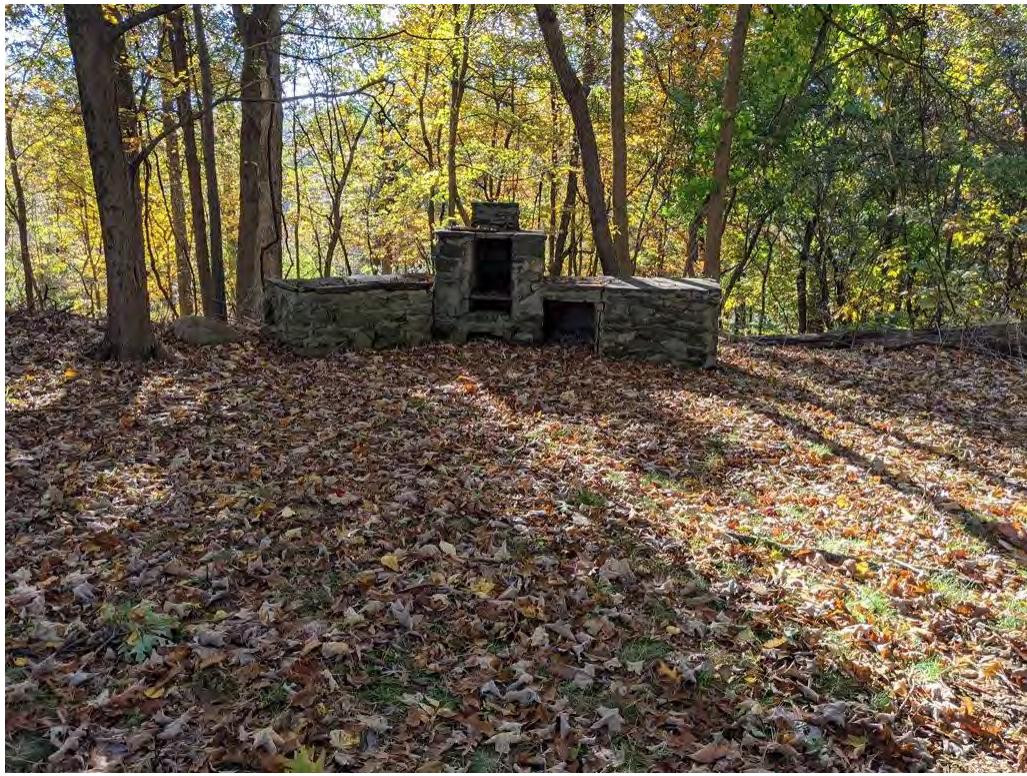
Photograph 7. Stone barbecue behind the main house in disturbed area. View looking southeast.

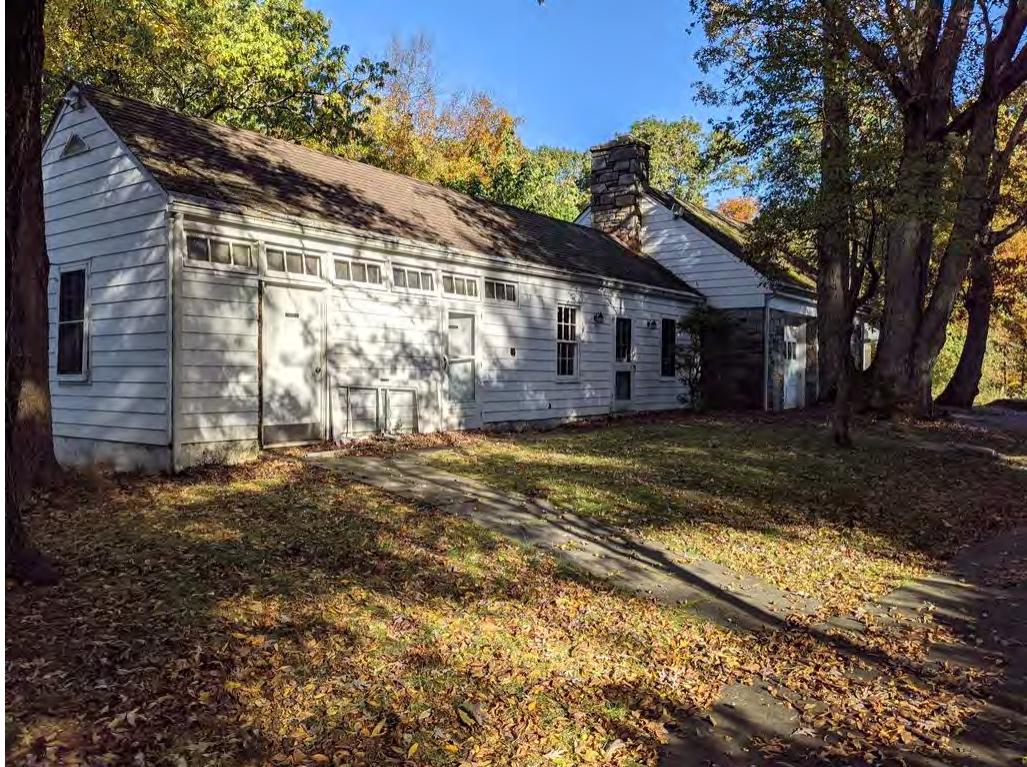
Photograph 8. The 1950s pool house and garage to the northwest of the main house. The dressing room doors are on the left. View looking north.

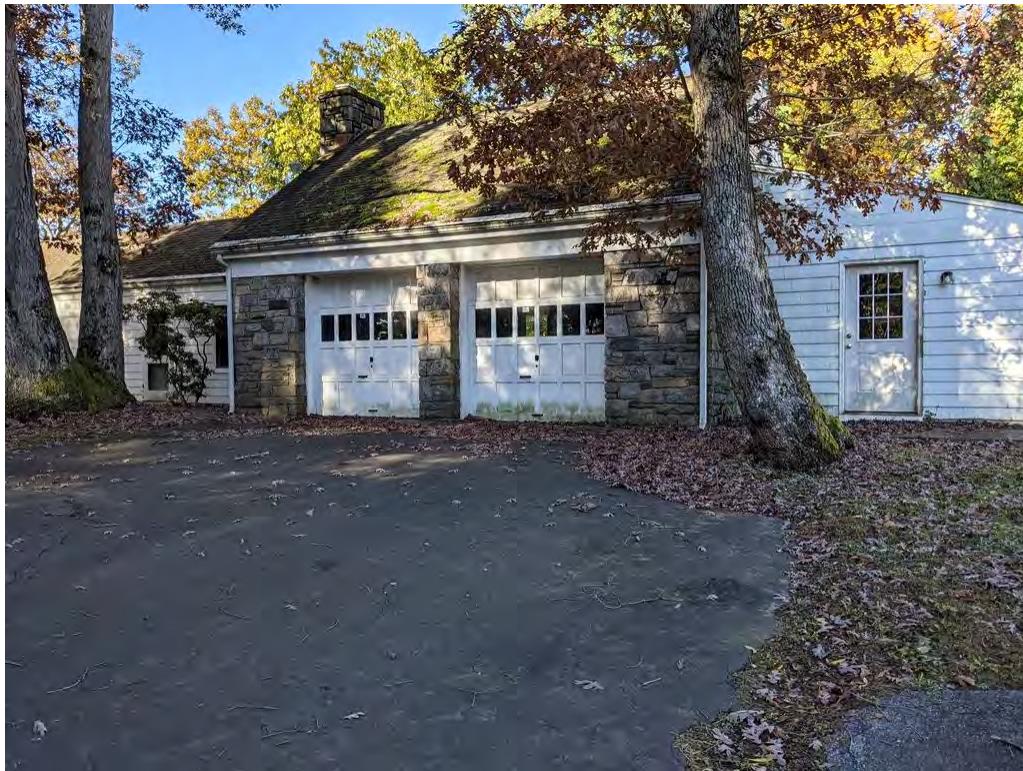
Photograph 9. The 1950s pool house and garage to the northwest of the main house, showing the garage. View looking southwest.

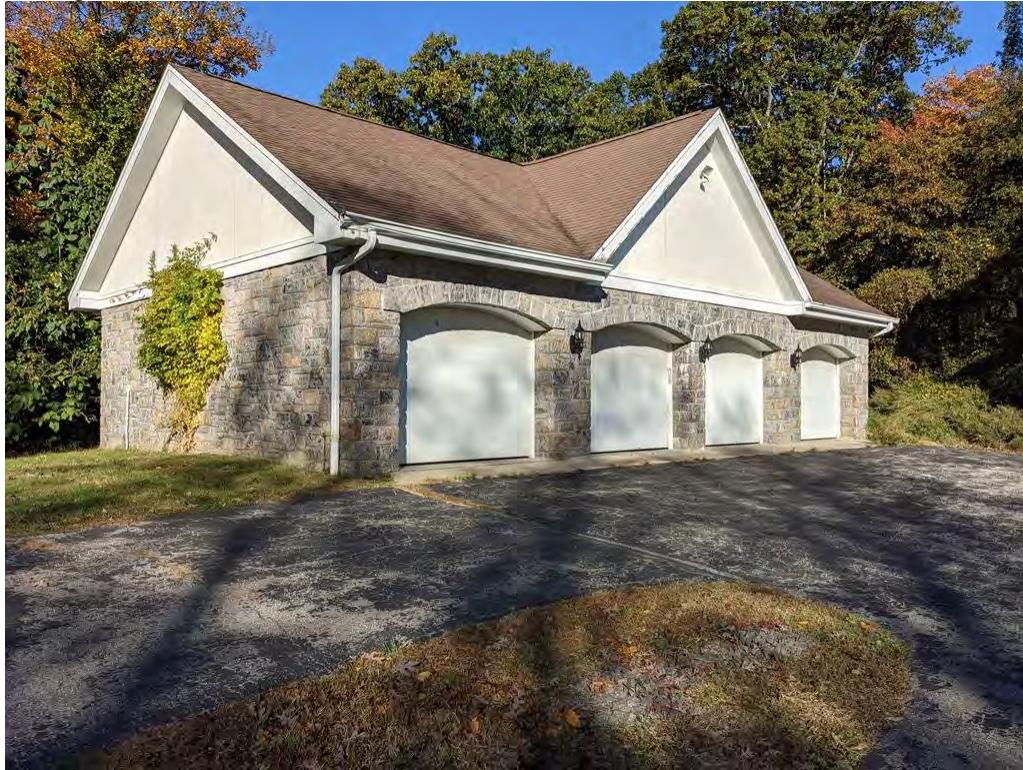
Photograph 10. The 1990s four-car garage, located north of the pool house/garage. View looking northwest.

Susan Cullman owned the project site until her death in 1994 and in 1996 the property passed to her daughter, Dorothy Cullman Treisman (Liber 11535: 259). Building permits show that at about this time the caretaker's dwelling was extended and the four-bay garage north of the pool house was erected, although Certificates of Occupancy were not issued until 2002, when Dorothy Cullman Treisman made additional changes to the property requiring a survey map that triggered municipal review. The survey map from 2002 (Figure 14) showed that the extreme southwestern corner of the original property was divided and sold to a new owner that year, leaving the project site at 37.18 acres. The current buildings on the project site were erroneously depicted on this survey as

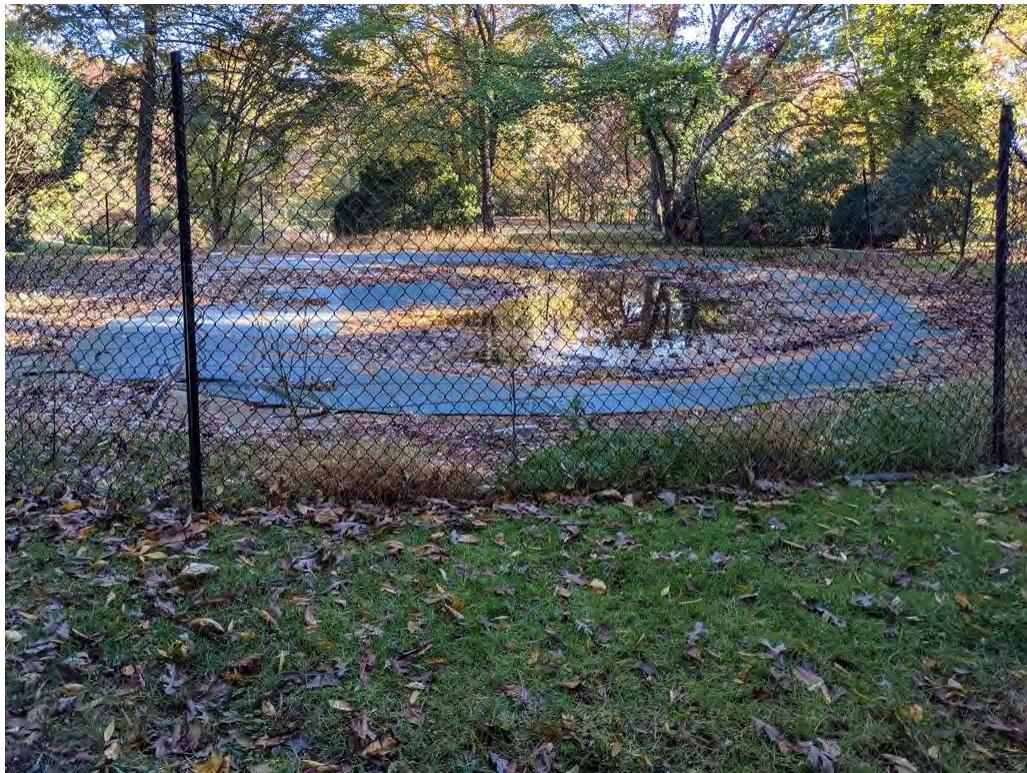
Photograph 11. The kidney-shaped swimming pool between the main house and the pool house/garage. View looking northeast.

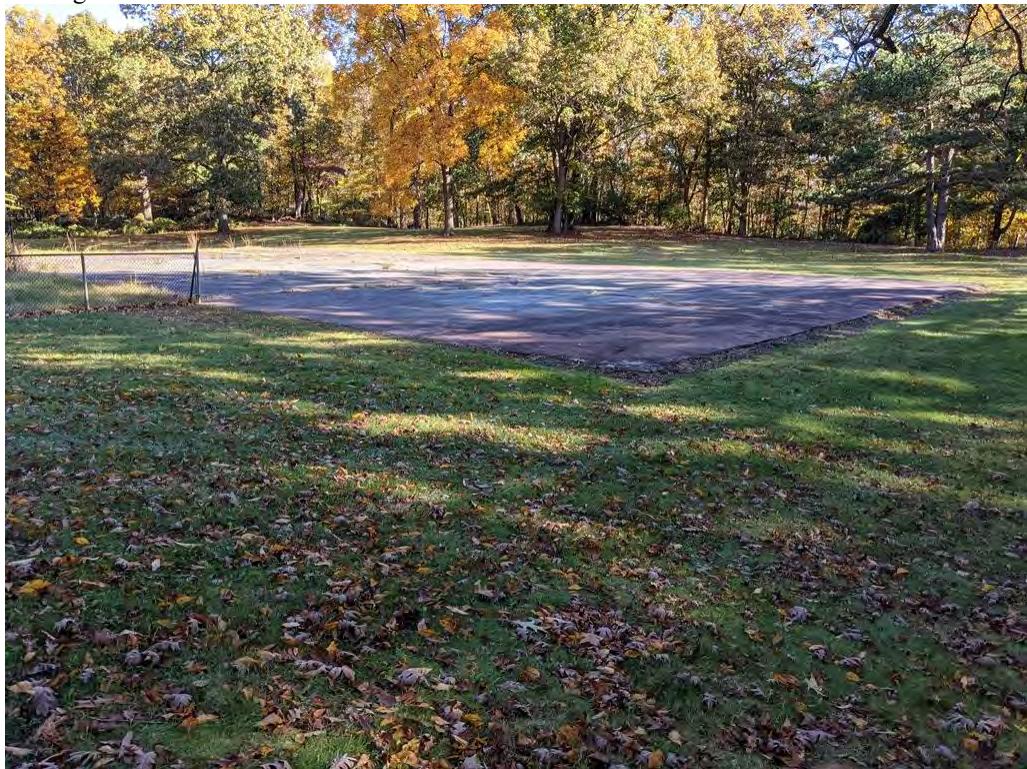
Photograph 12. The former tennis court north of the main house. The entry driveway is in the far background. View looking northeast.

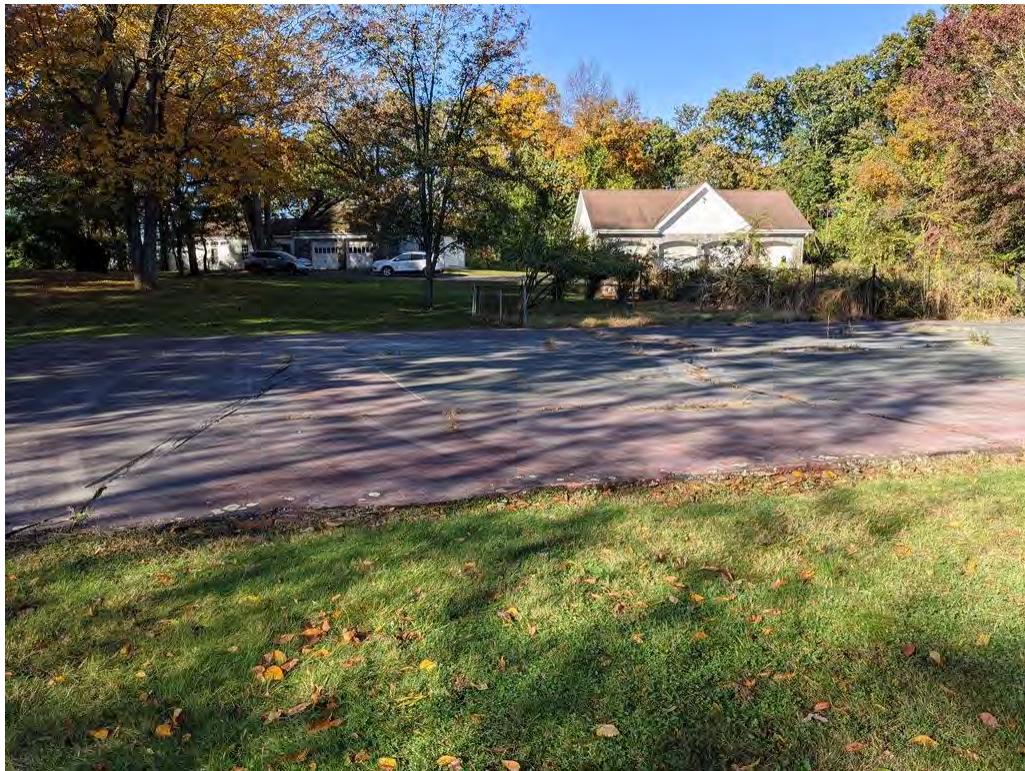
Photograph 13. The former tennis court in the foreground, with the pool house/garage and four-car garage in the left and right background, respectively. A fenced overgrown former garden is located between the tennis court and the four-car garage. View looking west.

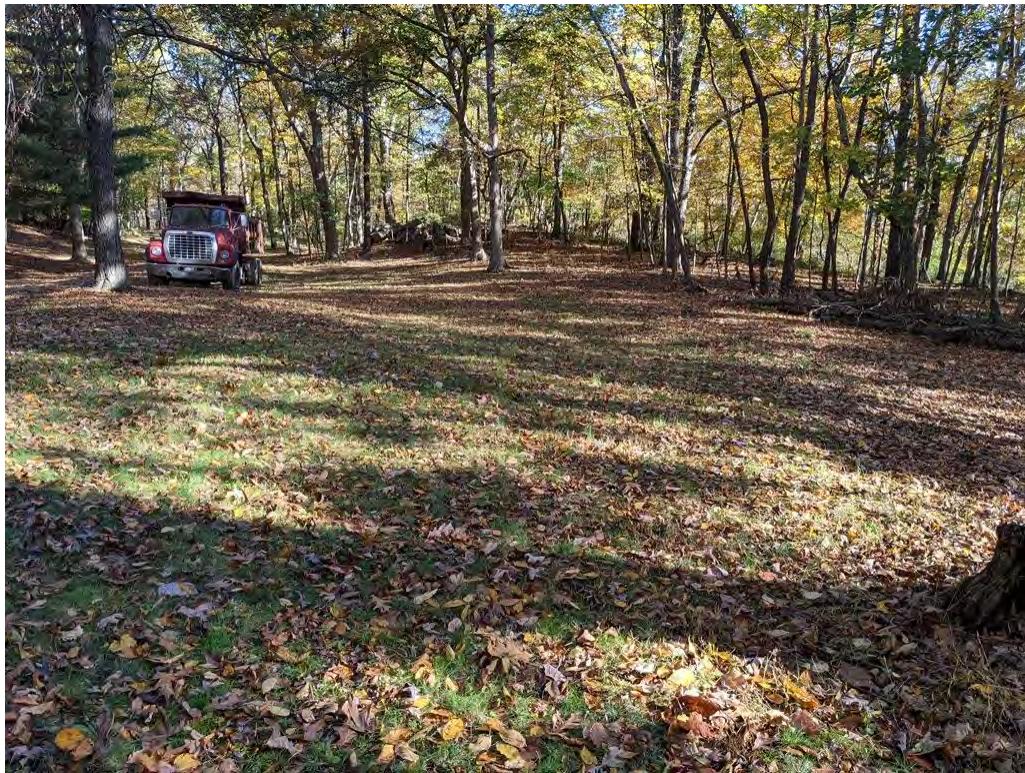
Photograph 17. The terraced and wooded area to the east of the entry driveway, with a substantial bedrock outcropping in the background. View looking northeast.

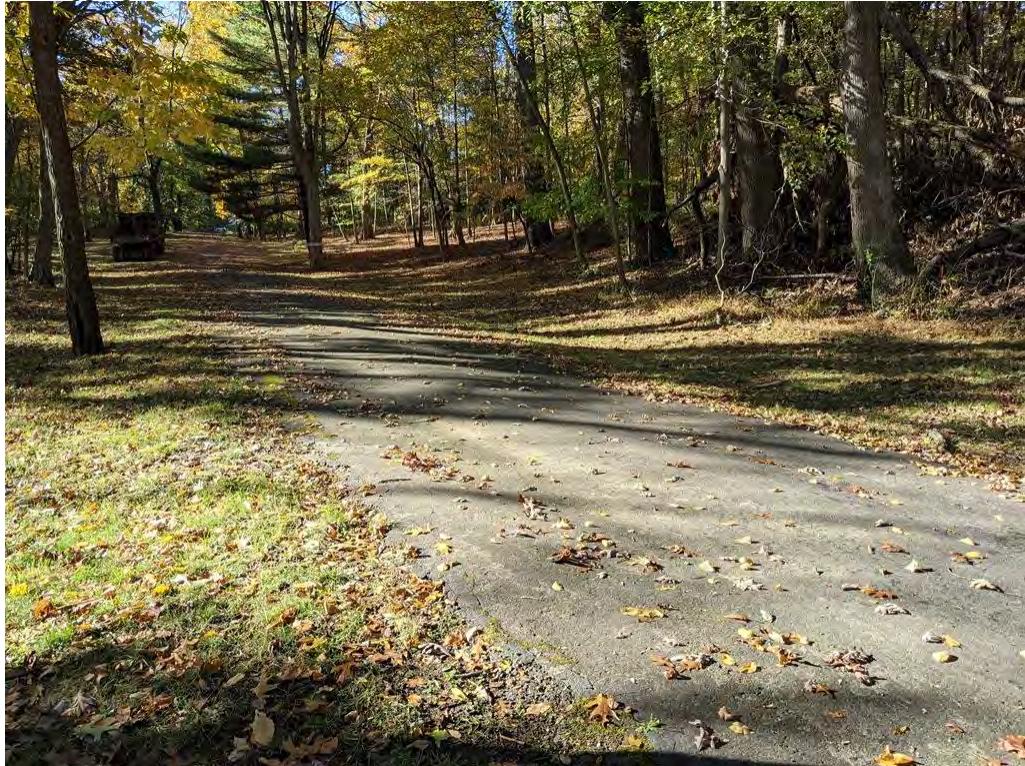
Photograph 18. The entry driveway leading to the main house, with wooded areas on both sides, and a large bedrock outcropping on the right. View looking southwest.

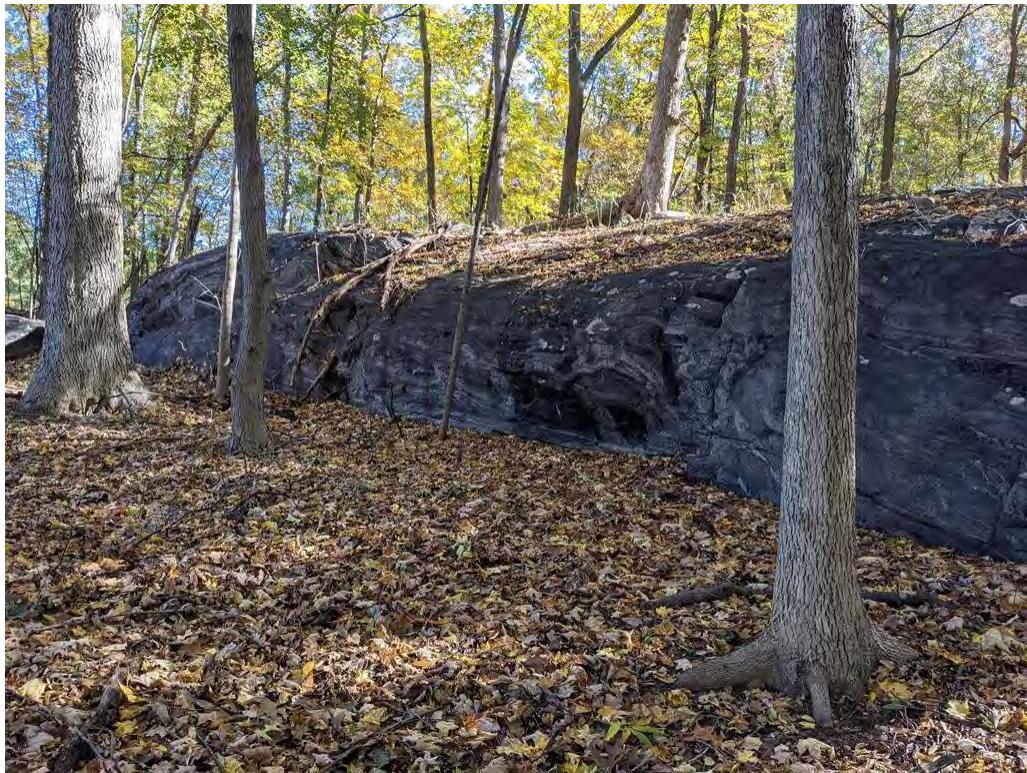
Photograph 25. A large, linear bedrock outcropping in the central western portion of the property. View looking northeast.

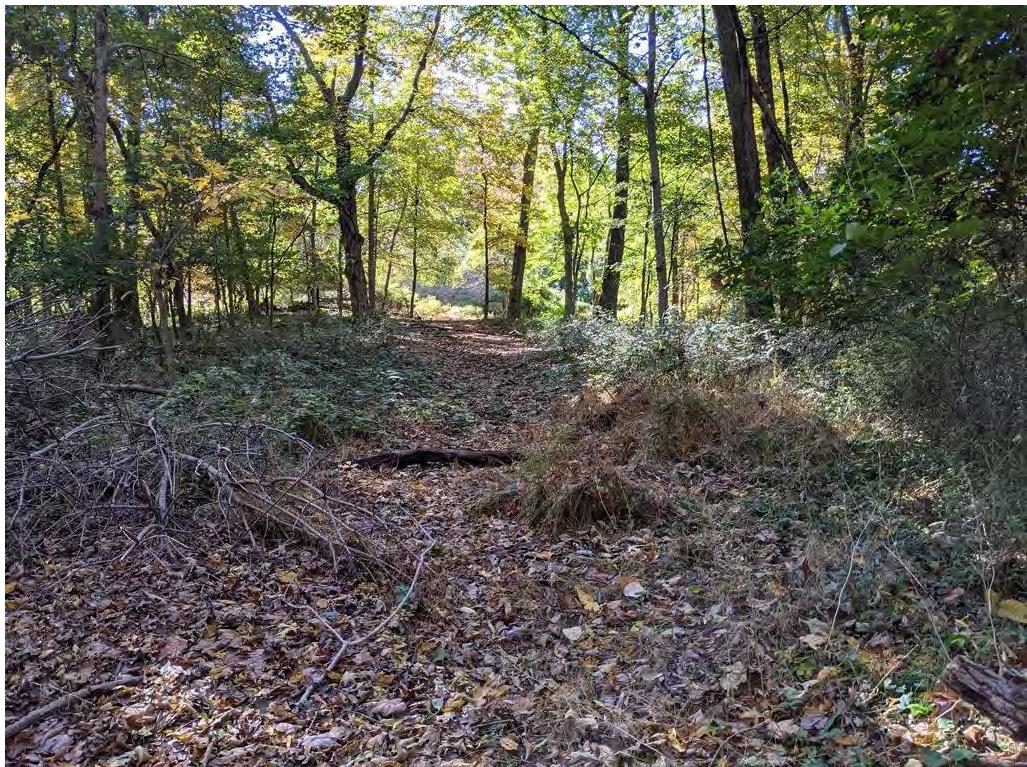
Photograph 26. An overgrown former access pathway running north-south through the property. View looking south.
