# **PHASE I ARCHAEOLOGICAL INVESTIGATION**

**Meadows at Briarcliff Subdivision  
715 Sleepy Hollow Road  
Briarcliff Manor, Town of Mount Pleasant  
Westchester County, New York 10510**

Historical Perspectives, Inc.  
PO Box 529  
Westport, CT 06881

**January 2022**

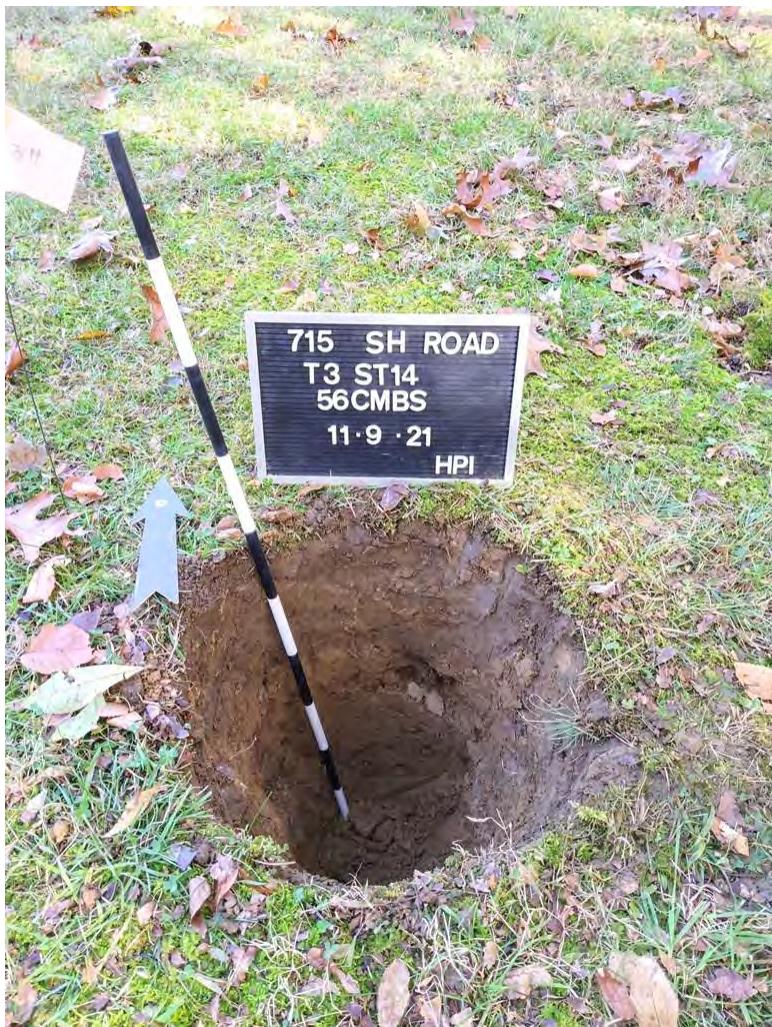
Photograph 28. Representative Shovel Test 3-14.

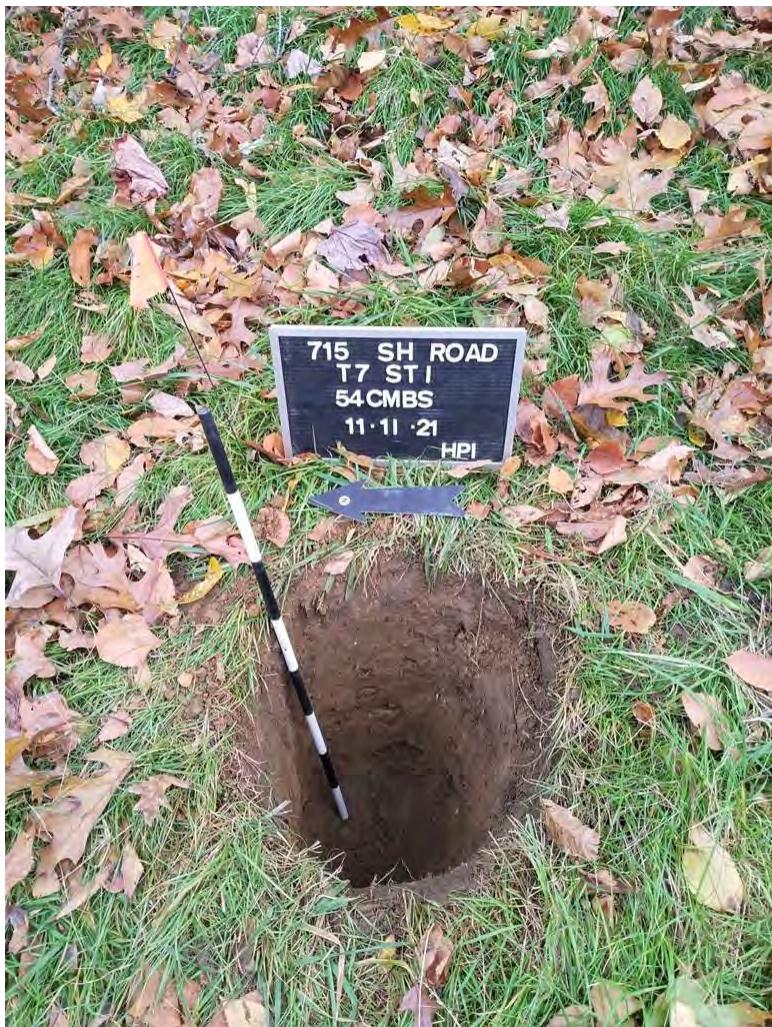
Photograph 29. Representative Shovel Test 7-1.

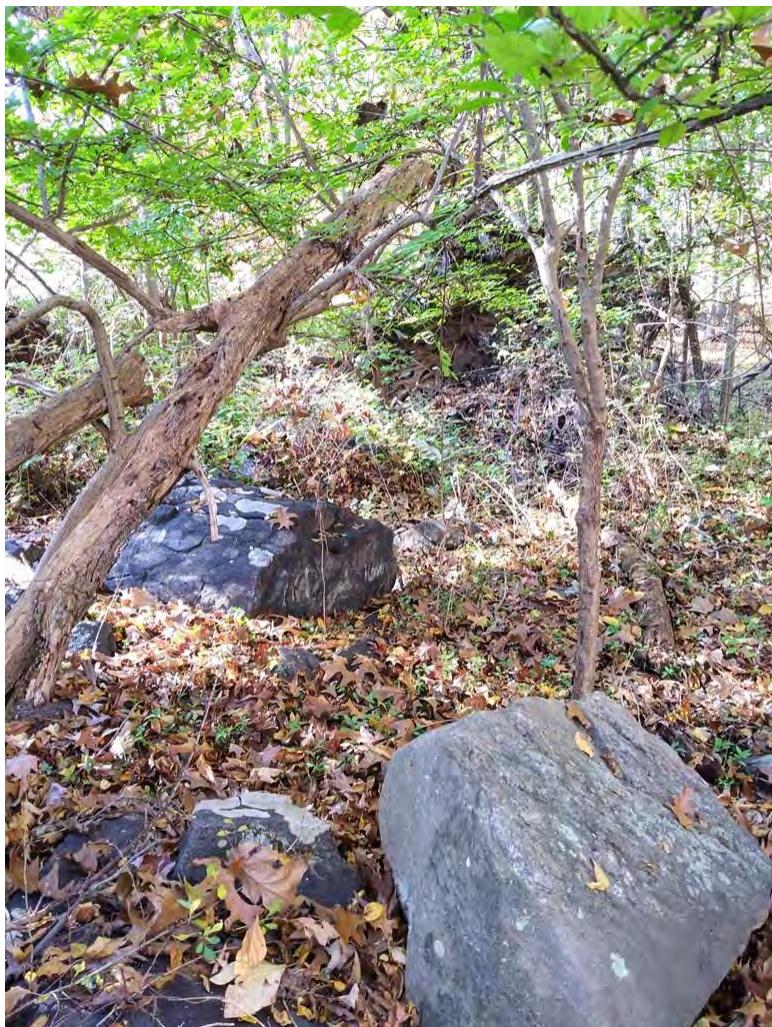
Photograph 30. Example of dense bedrock outcrops where shovel tests could not be excavated.

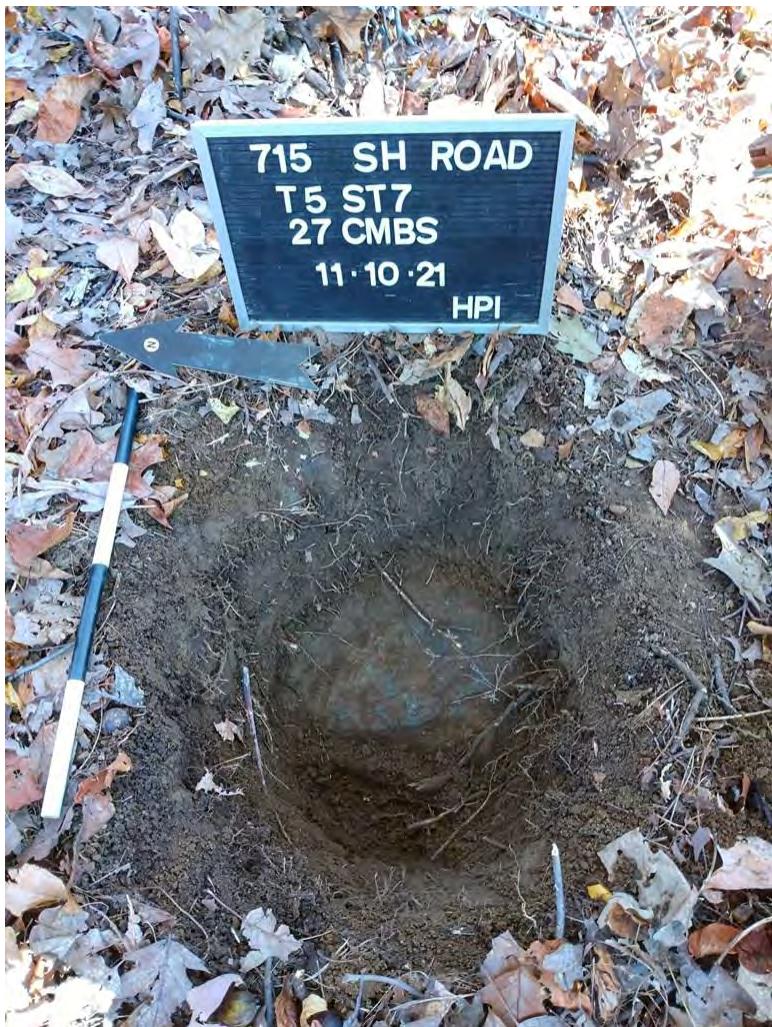
Photograph 31. Example of a rock impasse or shallow bedrock at Shovel Test 5-7.

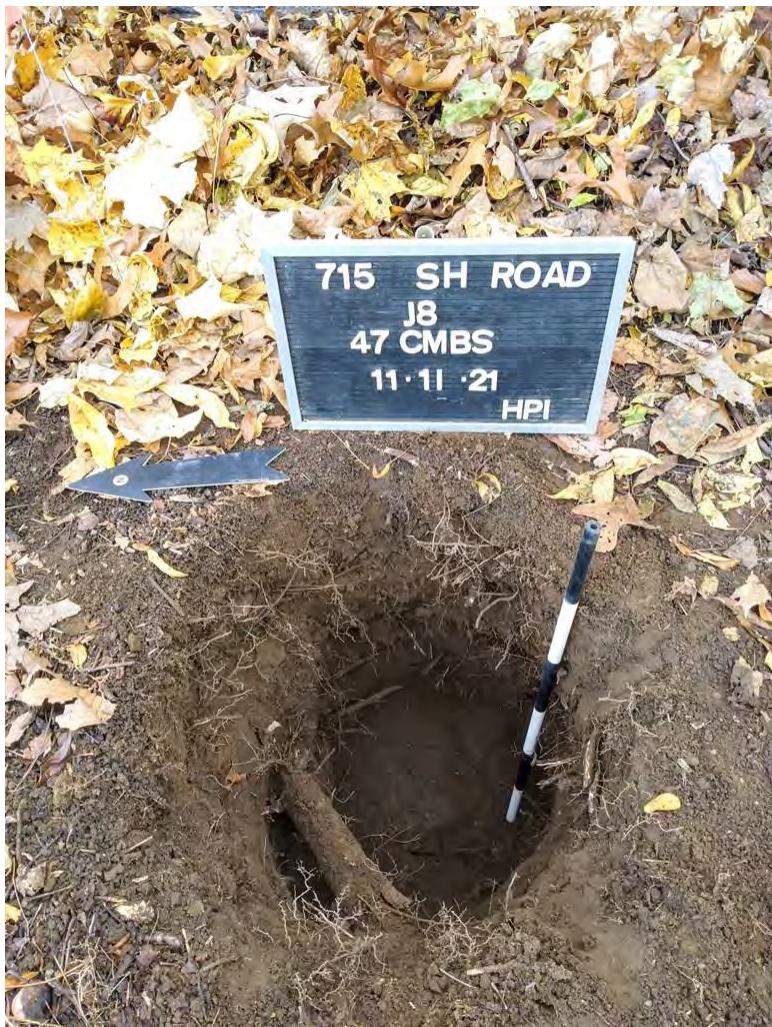
Photograph 32. Example of a rock impasse or bedrock at Shovel Test J-8.

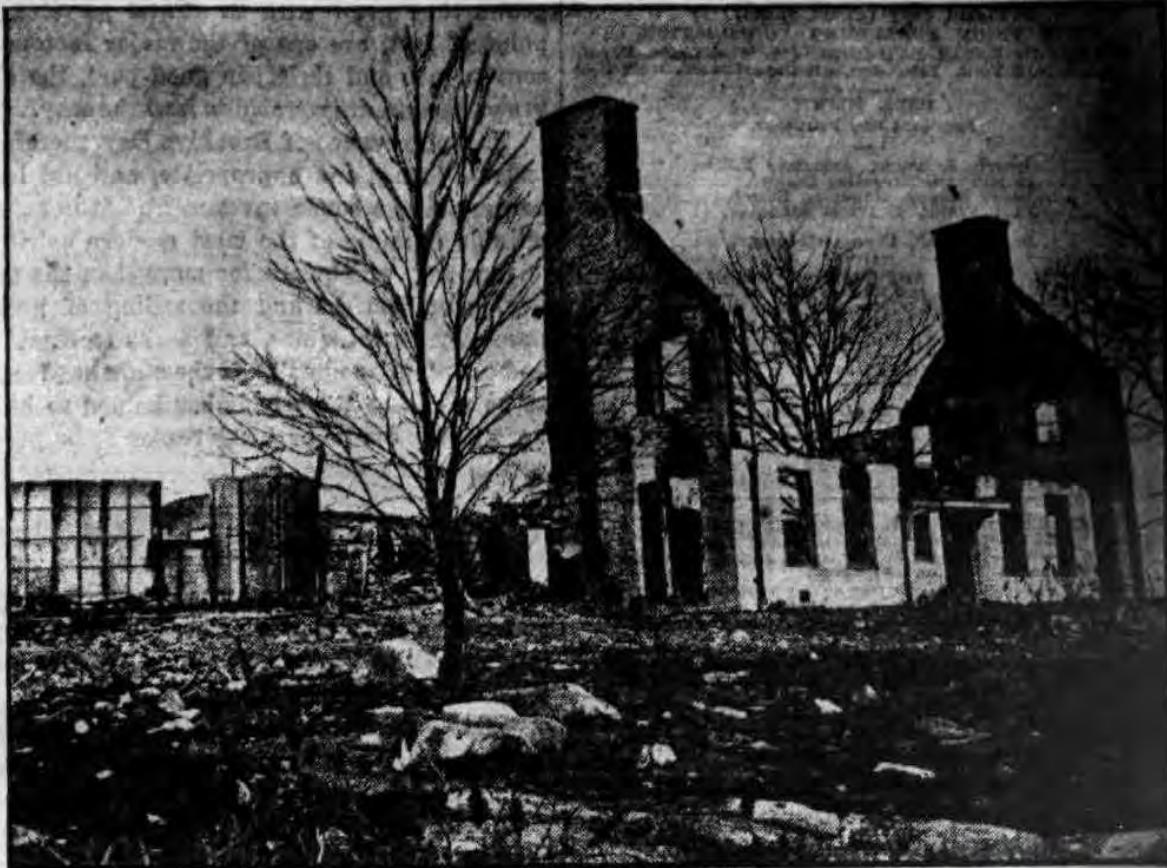
1929 photograph of the burned Dall home on the project site (Brooklyn, New York *Standard Union*).

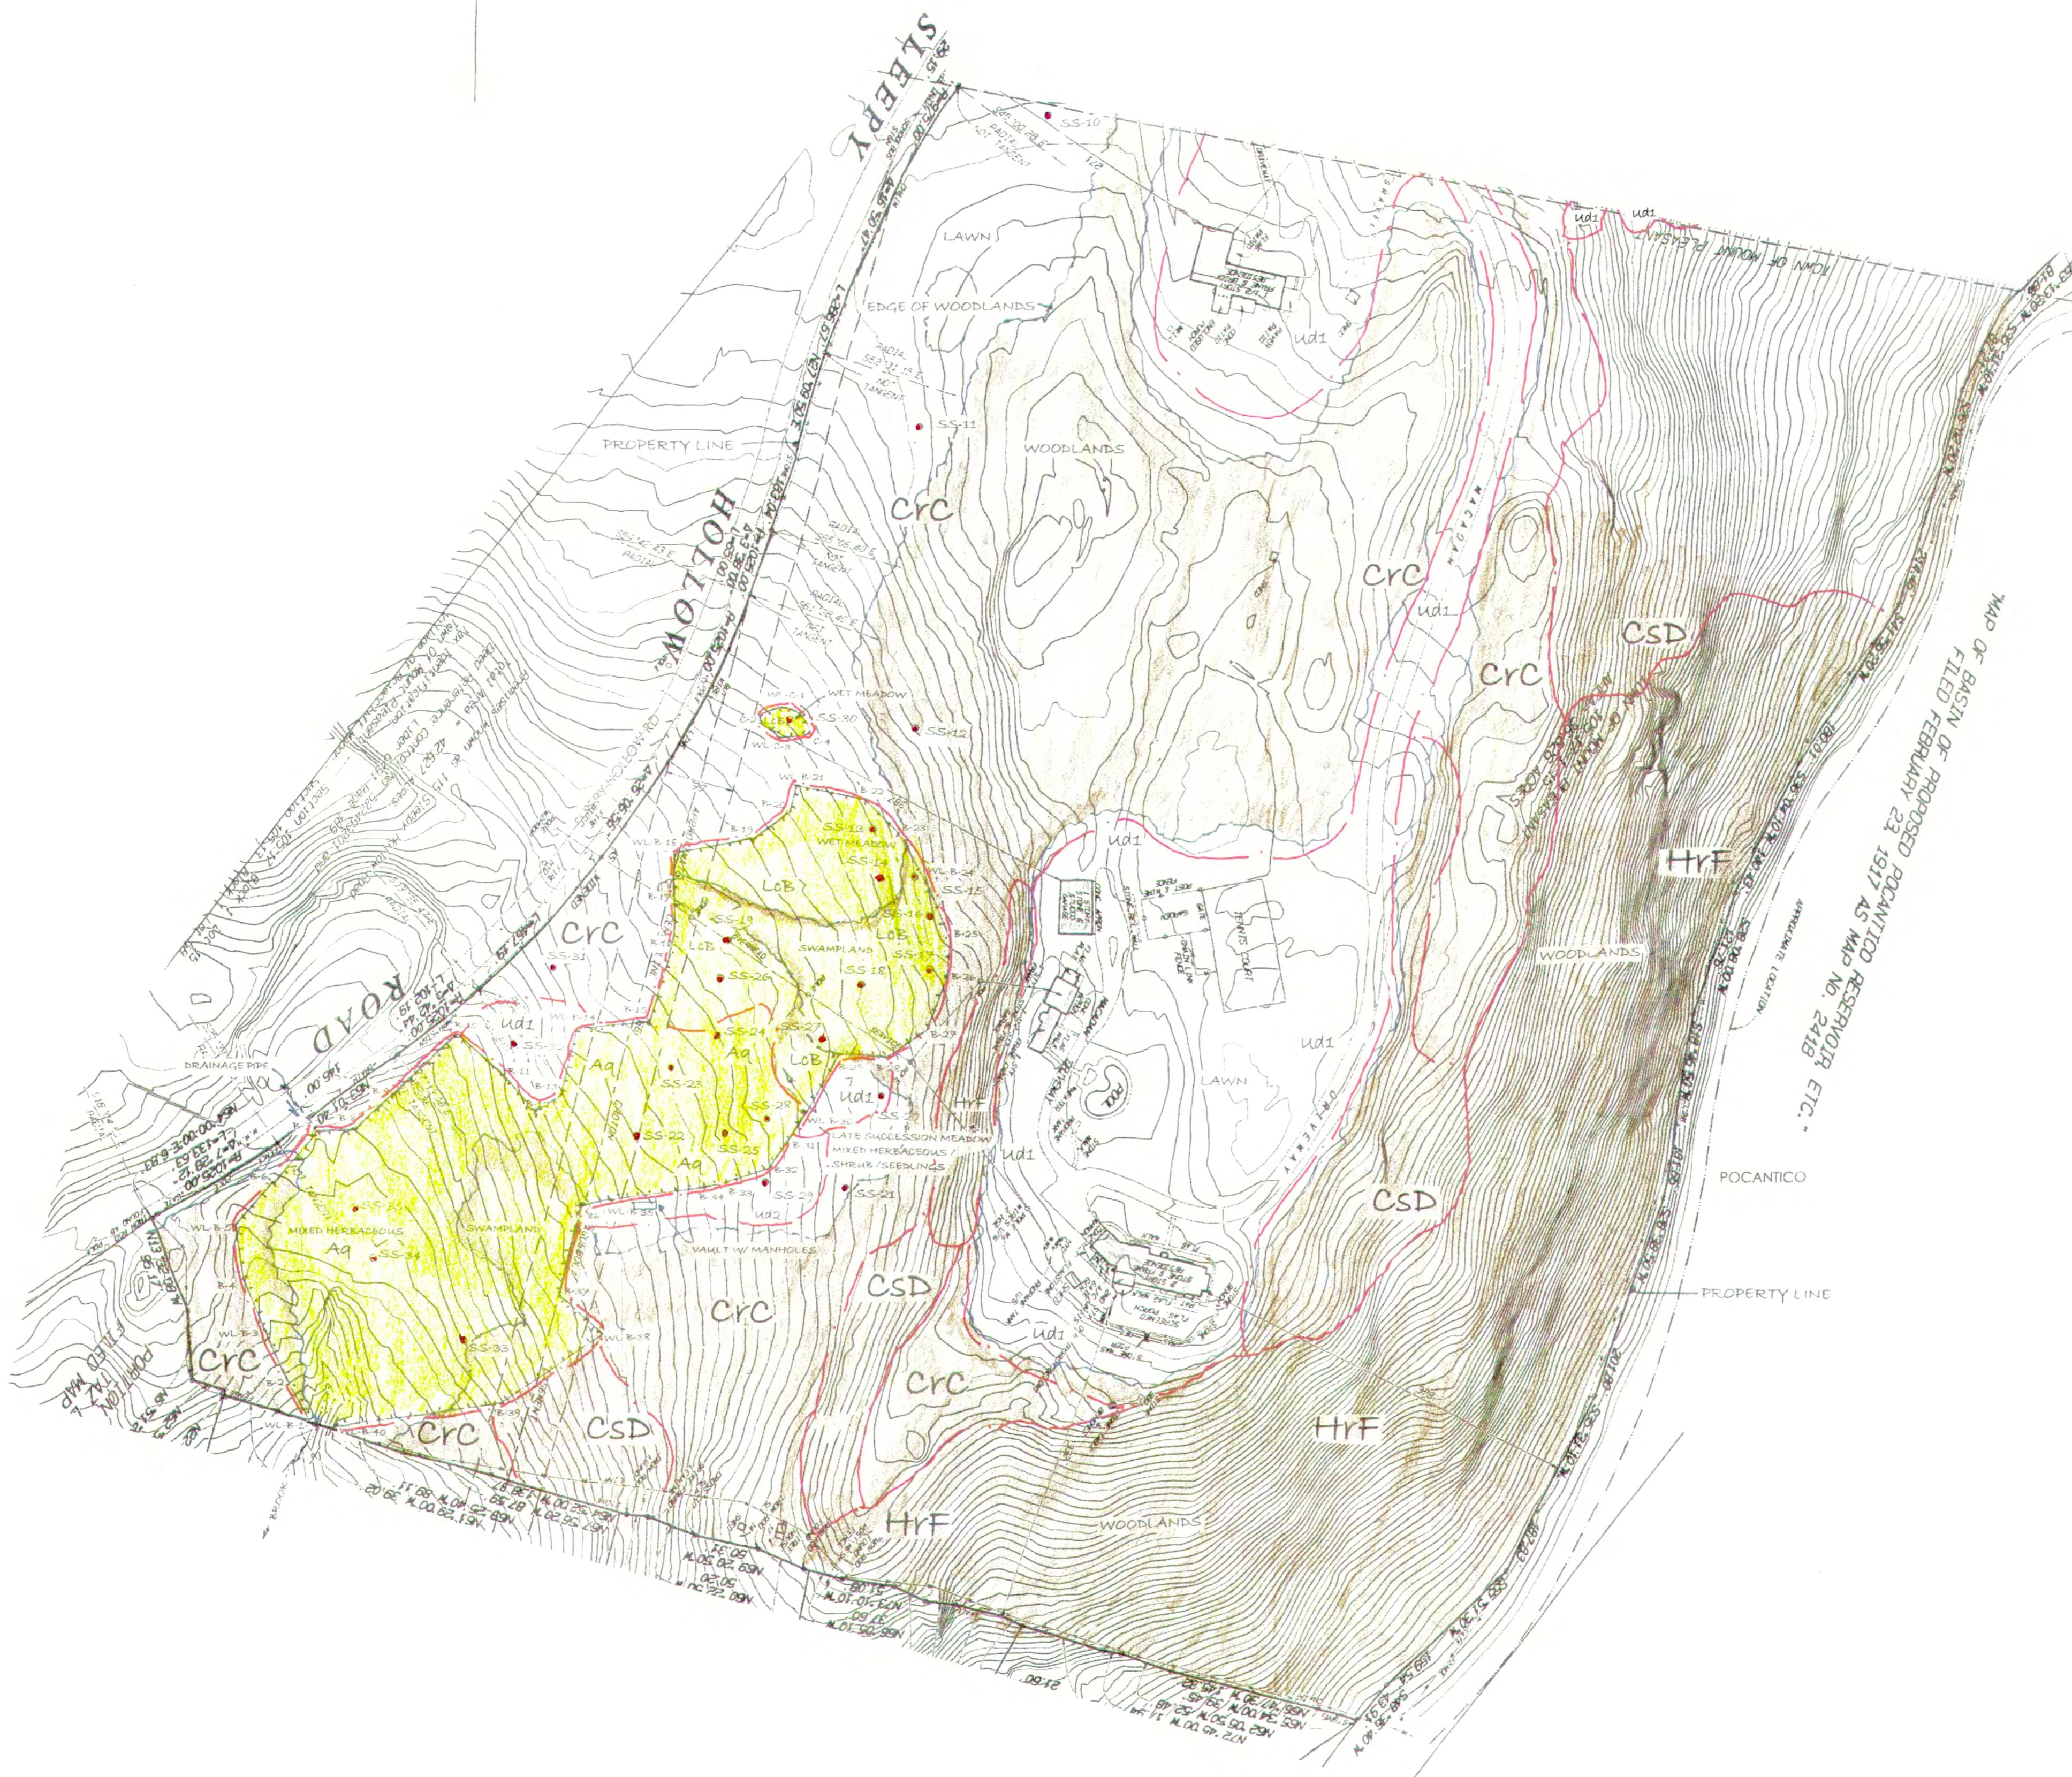
KEY TO MAP

SS-1	SOIL BORING LOCATION
WL-A-1	FLAGGED WETLAND BOUNDARY
WL-A-2	WL-A-3
ELEVATION CONTOUR IN FEET (ELEVATION VALUES UNSPECIFIED)	
SOILS INFORMATION	
NON-WETLAND SOILS	
CRC	Charlton-Chatfield complex, very rocky, well drained, slopes 2 to 15 %
CSD	Chatfield-Charlton complex, very rocky, well drained, slopes 15 to 35 %
HRF	Hollis-Rock outcrop complex, very steep, well drained, slopes 35 to 65 %
UDS	Udorthents soils, well drained, slopes varied
UDR	Udorthents soils, moderately well drained, slopes varied
WETLAND SOILS	
Aq	Aquents, poorly drained, slopes 0 to 3 %
Lb	Leicester loam, poorly drained, slopes 3 to 8 %
UD	Soils Boundary
CRC	Charlton-Chatfield complex, very rocky, well drained, slopes 2 to 15 %
