Re: Yeshivath Viznitz
Special Permit Application
235 Elm Road, Briarcliff Manor, NY

Building Inspection Report for Howard Johnson Hall

235 Elm Road,
Briarcliff Manor, NY 10510
(Aug 11th, 2021)

Building Inspection Report for Hillside House

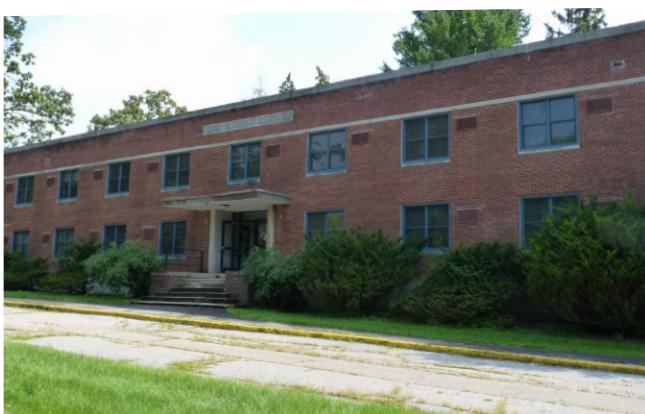
PICTURE #3

- The 6" precast concrete band above the second floor windows appears to be in fair conditions except for sporadic chips on the surface and above lintels which should definitely be repaired and patched to prevent future water infiltration. (PICTURE #3, #9 & #11)

- Parapet wall precast concrete coping and window sills need to be power washed and cleaned properly. (PICTURE #1, #3, #9, #10 & #11)
- Brick efflorescence and signs of prior repointing were observed at several locations. (PICTURE #8)

- Some existing steel window lintels were rusted. Window caulking was deteriorated at multiple locations. (PICTURE #9)
- Cracks were observed under the roof of the entrance canopy. (PICTURE #5)

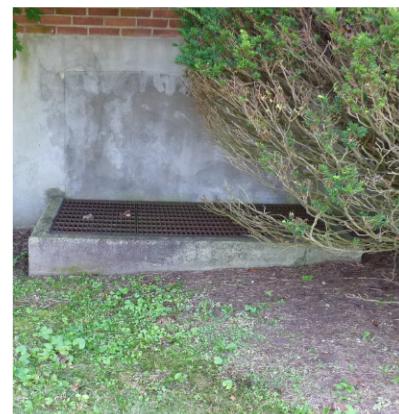
PICTURE #4

- Scuppers were found at left and right side of the front elevation and no downspouts were connected to the scuppers. Rain from the scuppers is draining directly on the facade surface. (PICTURE #1 & #4)

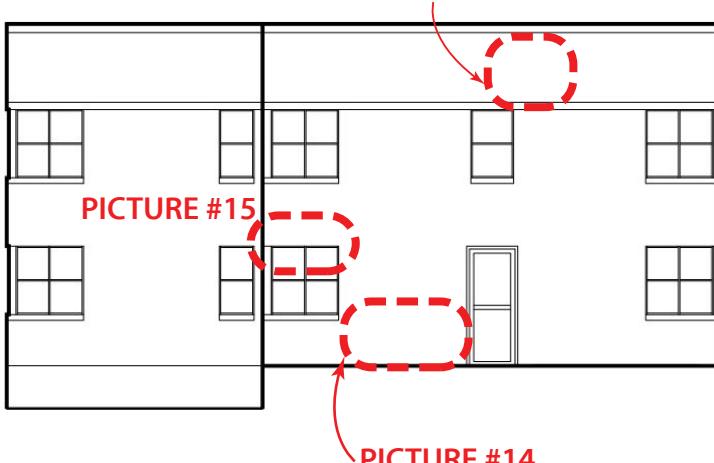
PICTURE #13

- Brick wall at right elevation is in fairly decent condition. (PICTURE #13)
- Brick efflorescence was observed at indicated locations. (PICTURE #14)
- Some existing steel window lintels were rusted. Window caulking was deteriorated at multiple locations. (PICTURE #13, #15)
- Scuppers were found at the right elevation and no downspouts were connected to the scuppers. Rain from the scuppers is draining directly on the facade surface. (PICTURE #16)
- Parapet wall precast concrete coping and window sills need to be power washed and cleaned properly. (PICTURE #13)
- Existing HVAC louvers to be checked & secured and all around louvers shall be sealed as necessary.

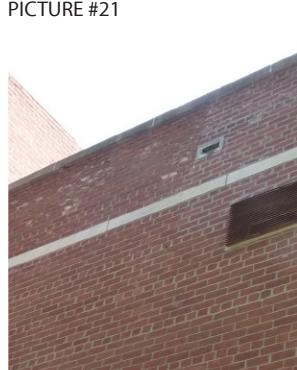
PICTURE #24

- Brick wall at rear elevation is in fairly decent conditions except for an extensive portion of the rear and inner parapets. (PICTURE #21 to #27)
- The 6" precast concrete band above the second floor windows appears to be in fair conditions except for sporadic chips on the surface and above lintels which should definitely be repaired and patched to prevent future water infiltration. (PICTURE #22, #24, #26)

- Some existing steel window lintels were rusted. Window caulking was deteriorated at multiple locations. (PICTURE #23, #27)
- Scuppers were found at rear elevation and no downspouts were connected to the scuppers. Rain from the scupper is draining directly on the facade surface. (PICTURE #24)

- Parapet wall precast concrete coping and window sills need to be power washed and cleaned properly. (PICTURE #22, #24, #26 & #27)
- Existing HVAC louvers to be checked & secured and all around louvers shall be sealed as necessary.

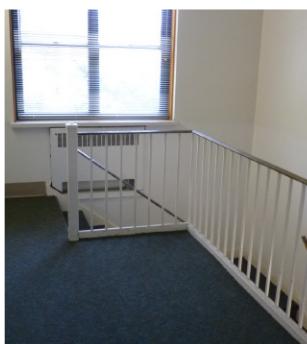
PICTURE #29

- The interior concrete structural floor (with commercial carpet flooring), dropped acoustic ceiling in the hallways, gypsum board ceiling in rooms, 6" CMU interior partition walls and light weight stud walls are all in fairly decent conditions. (PICTURE #28 & #34)
- Existing stairs and railing are up to code with blasters at 4" O.C. and proper height from finish floor surface. (PICTURE #29)
- Existing bathroom fixtures are in good condition but perhaps in need of some cosmetic upgrades. (PICTURE #30, #32)
- Radiator covers at both ends of the 2nd floor hallway were damaged. (PICTURE #35)
- Signs of severe water infiltration and damages to interior of building was noted above window in direct correspondence with compromised and badly rusted steel lintel on the exterior facade of the building. (PICTURE #33)

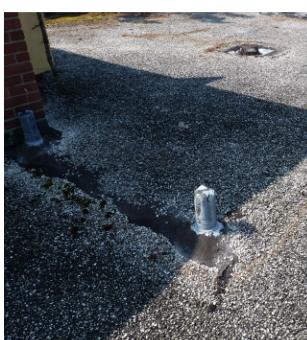
PICTURE #40

- In general, the existing roof seems to be in fairly decent condition and no obvious leakage was found at the 2nd floor ceiling.
- Existing EPDM membrane seems to be in fair condition and no obvious damage was observed. (PICTURE #41)

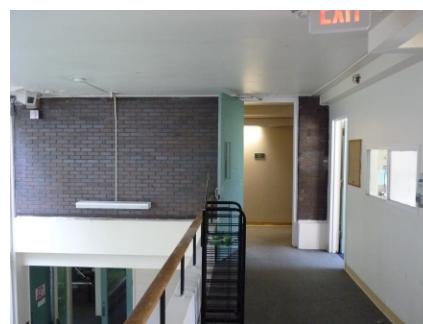
PICTURE #19

- The interior floors are structural concrete with commercial carpet flooring and 6" brick/CMU interior partitions. (PICTURE #18, #19, #20)
- Existing rooms are in good conditions with minor signs of water infiltration. (PICTURE #21)
- Existing stairs' railings are not up to code and further investigation will be necessary to assess existing railings and stairs in terms of sizes and ADA compliance. (PICTURE #22)
- Existing exit signs and emergency lights appears to be in fair condition but will definitely need to be tested by a licensed electrician. (PICTURE #19,#22)
- Existing bathroom facilities are still functional and in fair conditions.
- Some severe signs of water penetration were noted at both ends of the 2nd floor hallways. (PICTURE #23-a and #23-b)

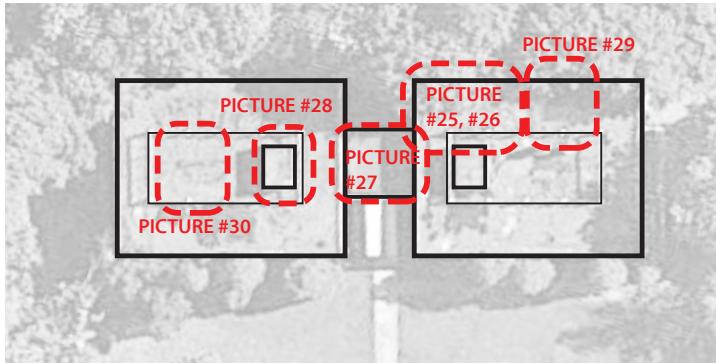
Hillside House Roof Plan

- Entire roof is severely compromised. The roof is not draining properly and there is considerable vegetation growth over the roof. (PICTURE #24 to #30)
- Entire roof is not properly pitched and ponding was observed pretty much everywhere. (PICTURE #24 to #30)
- Left side roof bulkhead is compromised, existing bulkhead ceiling is deteriorated. (PICTURE #28)
- Existing roofing EPDM membrane is in bad condition and should be replaced entirely. (PICTURE #29)
- Existing bulkhead walls and chimney reglets are in bad conditions. Also severe brick efflorescence was observed. (PICTURE #30)
